FINAL TECHNICAL REPORT

Project Title: **Multiphase Nano-Composite Coatings for Achieving Energy Optimization**

DOE Award Number: DE-EE0003489

Recipient Organization: UES, Inc.
 4401 Dayton-Xenia Rd.
 Dayton, OH 45432

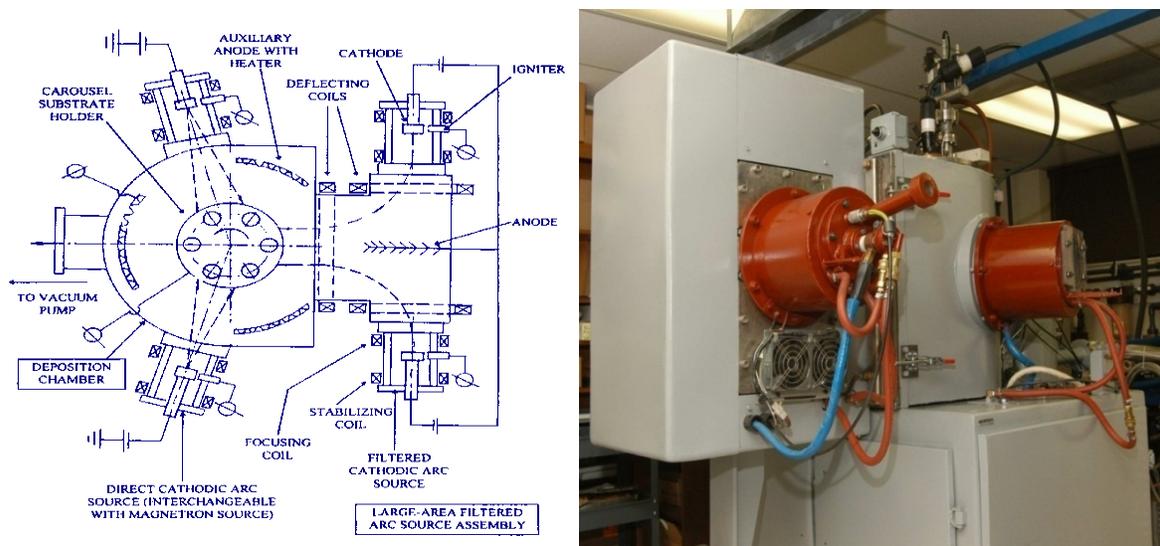
Figure 1. Schematic diagram of the Large Area Filtered Arc Deposition system (LAFAD)

A schematic diagram of the coating deposition system is shown in Figure 1. Essentially the system consists of a rectangular chamber with two large area filtered arc sources and deflecting magnetic coil assembly, and a cylindrical deposition chamber with two direct arc sources and an auxiliary anode assembly. The direct arc sources can be replaced by two magnetron sputter sources thus enabling a hybrid coating deposition process combining filtered arc and sputtering. Appropriate gases were introduced into the deposition chamber for reactive deposition. The auxiliary anode assembly facilitates the generation of a highly ionized metal and/or gas plasma in which the substrate can be immersed. The deposition chamber has a built-in carousel type double planetary rotation system for mounting substrates. Overall, the system is capable of accommodating relatively large complex shaped parts for coating deposition.

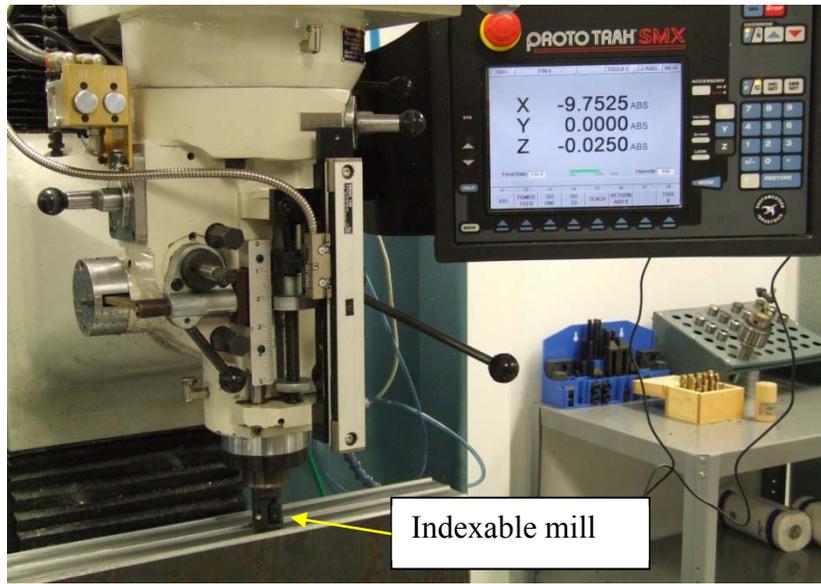
Figure 2. Pro-Track CNC CMX mill used for in-house testing of tool coatings

An index-able end-mill with two triangular inserts was used as milling edges. These inserts were used in dry cutting condition on a Pro-Track SMX CNC mill (see Figure 2). It is a programmable cutting mill that kept the parameters constant for each pass in each test. Figure 3 shows the index-able end mill carrying the triangular inserts. The diameter of the cut from edge to edge is 31.75 mm. At 1200 RPM, this gives a cutting speed of 120m/min. Obviously, it is in high-speed cutting regime.

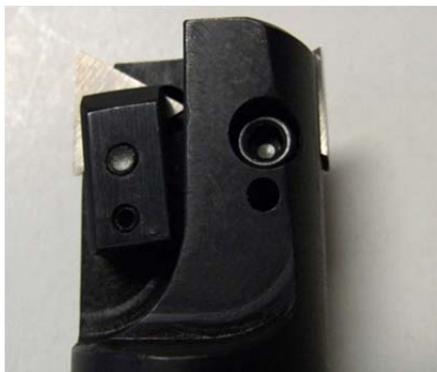
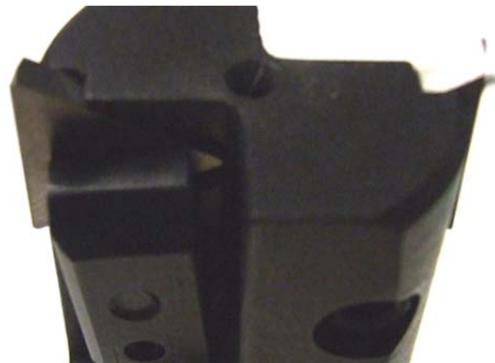
Figure 3. Photographs showing the index-able end-mill carrying the inserts

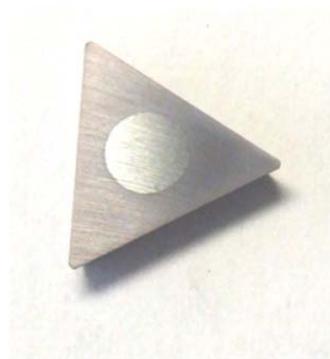
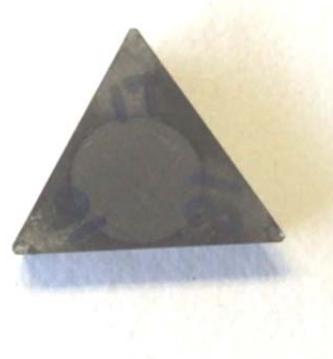
Figure 4. Typical coated inserts used in the accelerated tool deterioration study

Figure 4 shows the typical triangular insert used in this study. The actual volume of burned out tool is too small to measure. However, from the relationship between the surface area and the volume of small dimensional geometries, the burned out volume can be easily calculated. Optical microscopy with digital recording was used in this method. The next section describes this method in detail.

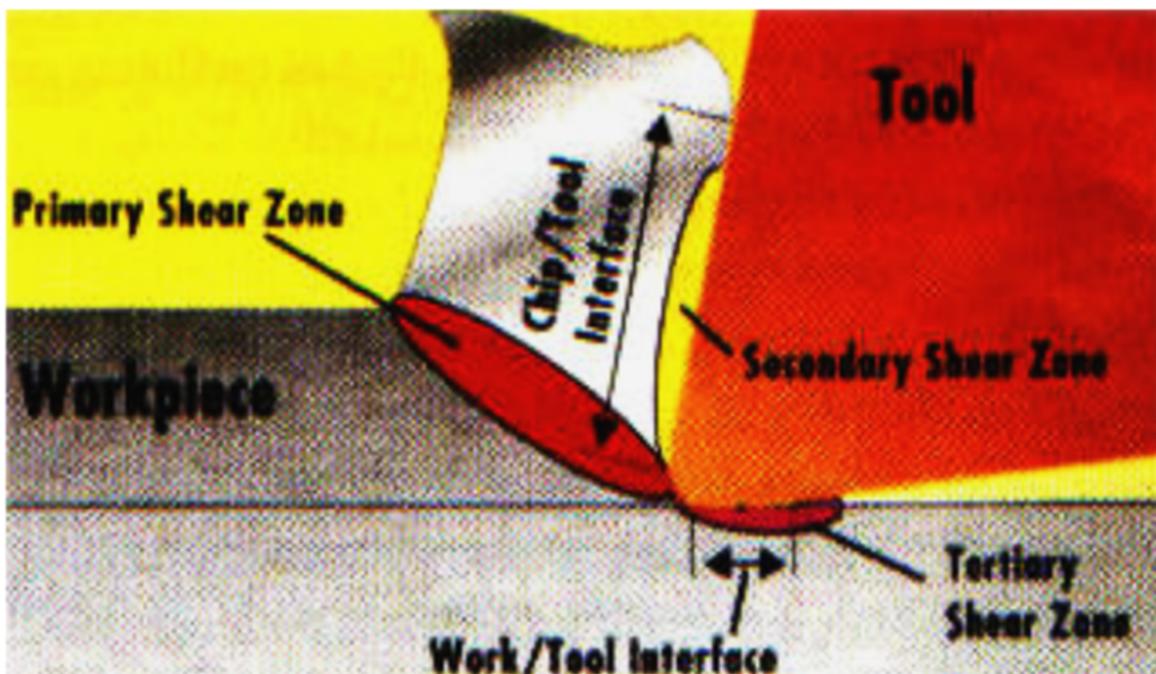
Figure 5. Schematic showing three main heat sources in cutting

Therefore, it is not obvious whether coatings influence the cutting process by an insulation effect (lower heat transmitted into the substrate), and/or by a tribological effect (lower level of heat created in the sources). Whatever it is, the heat generated in cutting process is the primary cause for the tool degradation. The volume of the tool burned-out in this heat is the basic factor affecting the tool life. Discoloration on the tool surface and the extent of discoloration acts as a significant signal before a catastrophic failure of the tool occurs. The obvious reason for this discoloration is the temperature gradient that is occurring during the cutting process. By observing this discoloration by an optical microscope the color change area can easily be detected and measured. Tools with maximum-burned volume (spread of discoloration) eventually cause the tool to chip and break away in catastrophic failure. This observation paved the basis for the accelerated evaluation method developed here. Figure 6 shows the typical burned-out pattern observed on tool edges (insert edge). The actual volume of burned out tool is too small to measure. However, the relationship between the surface area and the volume of small dimensional geometries could help to assess the burned-out volume.

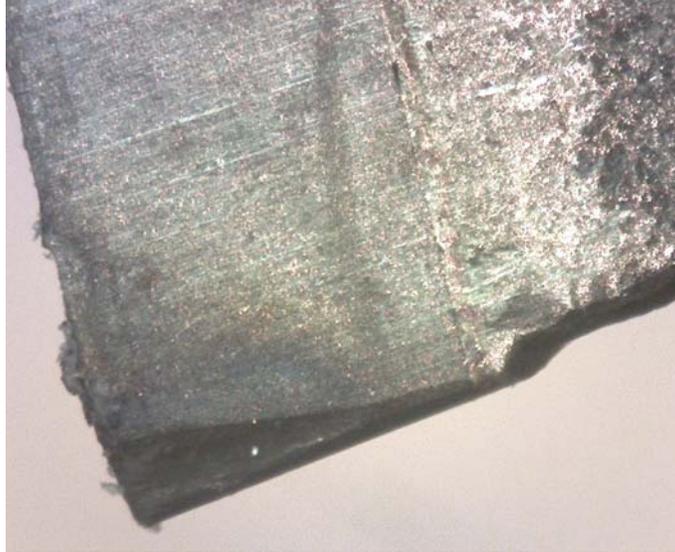
Figure 6. Burned area of a typical used insert (uncoated)

In this work, we have used an insert with three sides joining at a vertex of making approximately 60-90-90 degree angles between each edge (rectangular prism geometry, See Figure 6). Since the rake face is triangular and the insert can be mounted in three different positions, we can get three trials out of a single insert. We coated three of such tools with Greycho-I and Greycho-II. These tools were used to cut 12-20 rolled iron work-piece. The cutting conditions are given in Table 1.

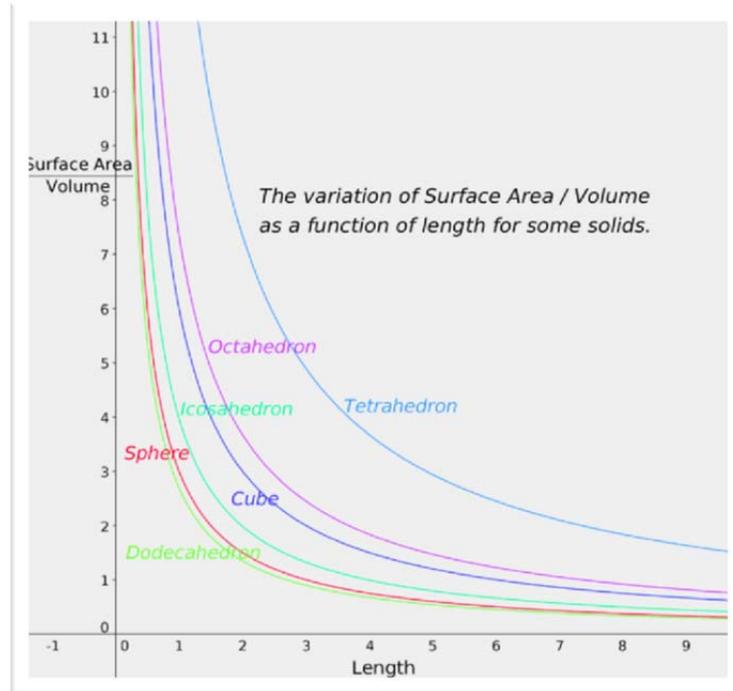
Figure 7. Relationship between length scales and the surface area to volume ratio for standard geometries

It can be seen that for any geometrical shape as the size get smaller the surface area to volume ratio get bigger (Figure 7). That means the small-burned volume in the used tool tips can be easily assessed by measuring the surface area measurements of the same geometrical shapes and thereby we can compare the efficiency of the coatings in protecting the tool tips from the so-called burned-outs.

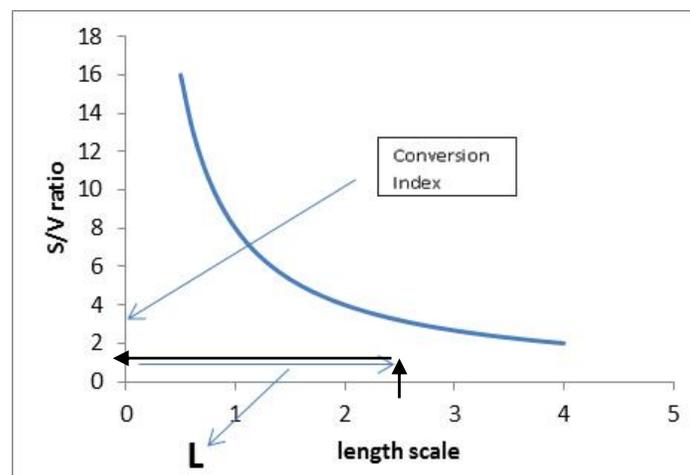
Figure 8. The graph connecting the surface to volume ratio for different size scale of a tetrahedron

Calculation of the burned out volume is based on the function connecting the size and the surface area to volume ratio of standard geometrical shapes described in the previous section. Figure 8 gives the graph connecting the surface to volume ratio and size scale of a tetrahedron. From this assumption, we can estimate the volume of the affected tool region from the graph shown in Figure 8 as follows.

By finding the corresponding S/V ratio for the average length L from the graph in Figure 8, we define an index of conversion α to be the ratio $\alpha = S/V$ corresponding to L. Burned out volume $V=S/\alpha$, where S is the measured total surface area from the optical microscopy.

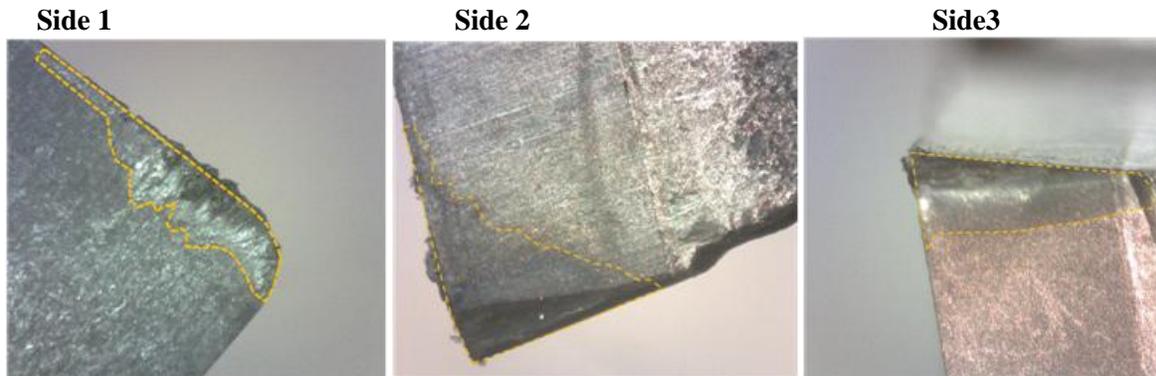
Figure 9. The burned-out area discoloration and contrast change as detected for three sides of an uncoated tool

In this section, burned out surface area measurement is described using an uncoated rectangular tool tip. The used tool is examined under an optical microscope and pictures were captured in jpeg format with same pixel density for each picture. The burned out area detected from the discoloration and contrast change was marked by a pattern as shown in Figure 9. As described before, for each side of the tool, actual burned out area was measured with the help of special software referred before. Adding three burned-out areas for each side, total burned out surface area was calculated. The minimum burned-out area shows the least damaged volume of the tool. The tool with minimum burned-out volume indicates maximum tool life.

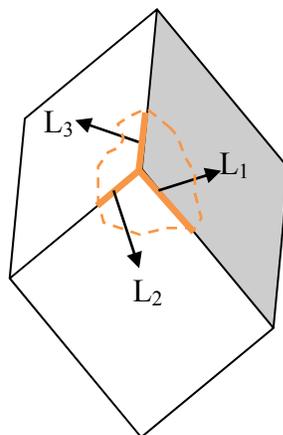
Figure 10. Schematic diagram showing the definition of length scale estimation

The burned out volume of each used tool can be calculated as follows. Let the length scale L of the affected region of tool be calculated from the edge lengths L_1 , L_2 and L_3 where L_1 , L_2 and L_3 are edge lengths related to the burned out areas as shown in Figure 10. Let us take L to be the average of these three edge lengths

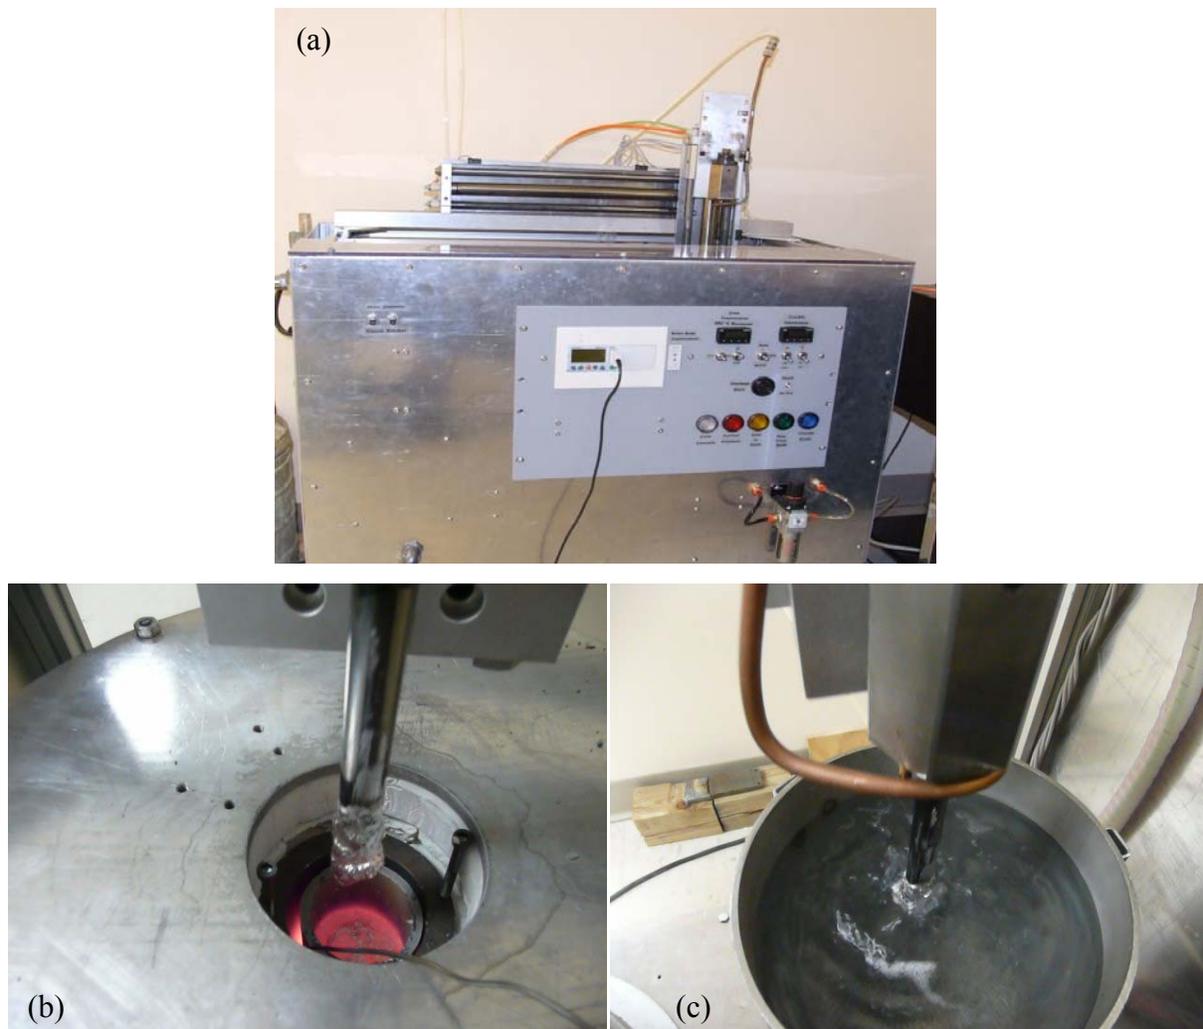
Figure 11. (a) Control board and mechanical arms (b) Molten Al bath (c) Cooling water reservoir

To evaluate aluminum die casting coatings, we designed an automatic in house metal dissolution/thermal cycling test setup. Figure 11 shows the thermal cycling test facility comprised of (a) the core pin handling arm and control board, (b) furnace for aluminum melting, (c) water quenching bath. This set up was used to transfer coated specimen between molten Al and water repeatedly creating the thermal cycling stress in the coating. We have tested our novel coating in this setup in comparison with TitanCoat™ coating. The difference between the initial weight and the weight after test is noted for each pin. After this, each pin is sectioned to characterize the thermal fatigue cracks under SEM.

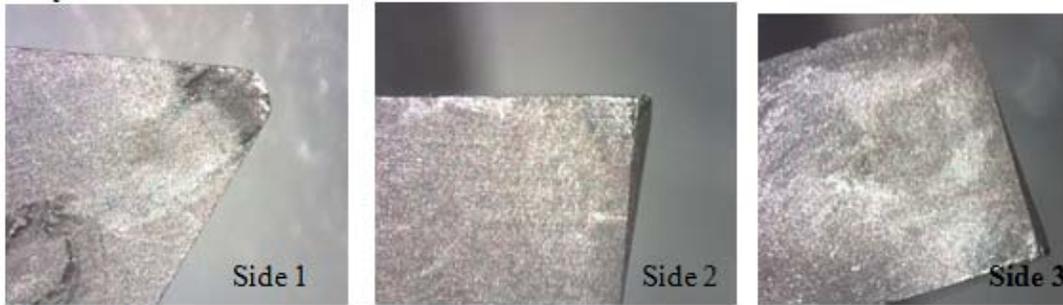
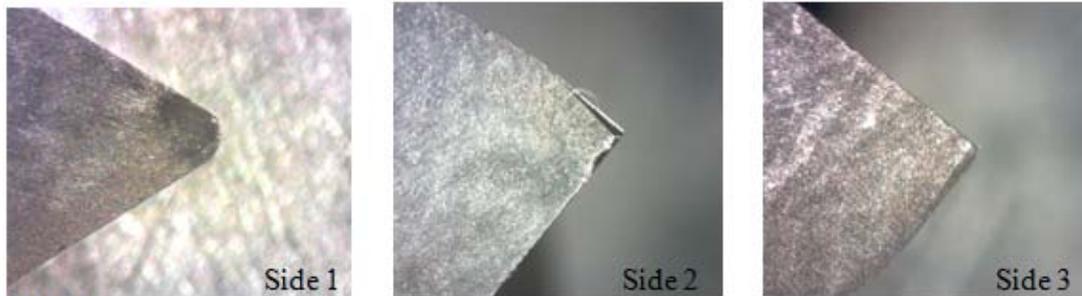
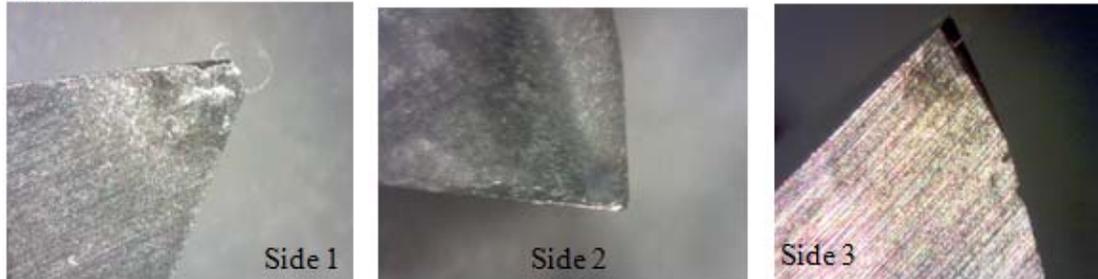
Figure 12. The burned-out area discoloration and contrast change as detected for three sides of each Triangular inserts used for coating evaluation

Figure 12 shows the cutting related discoloration (burned out area) and contrast observed from optical micrographs of Greycho coated tool tips along with the base line. As we can see, the discolored area for Greycho coated tools is significantly lesser than that of the uncoated baseline tool. The actual areas for these tools were calculated from these figures and burned out volumes were computed as described in Section 3.3.

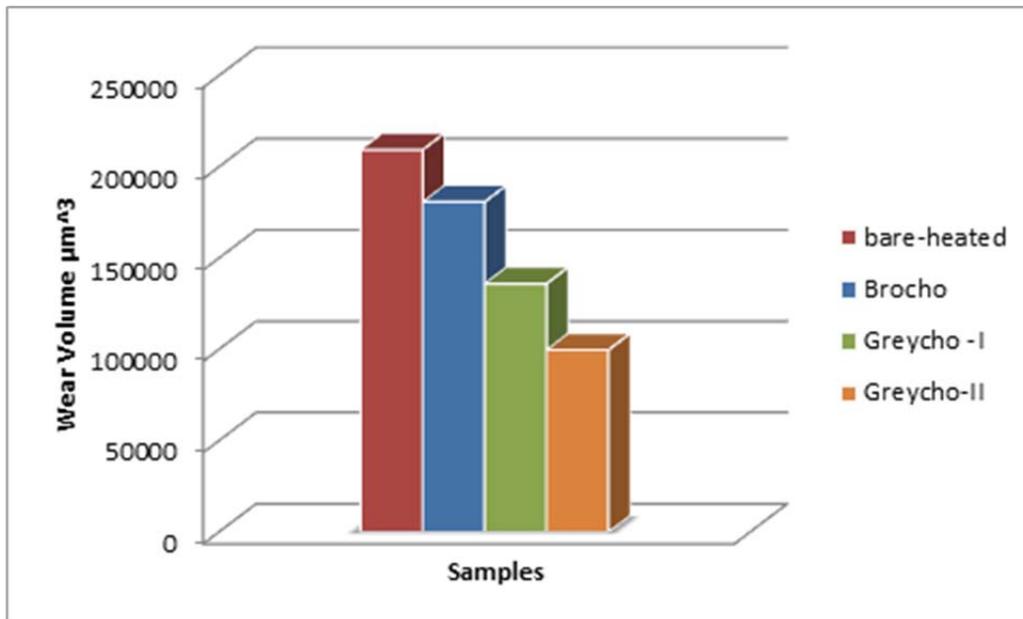
Figure 13. Total burned-out volume of various coatings compared to uncoated sample

Results of these measurements are shown in Figure 13. From Figure 13 it is evident that tool with Greycho-II™ coating has least wear-burned volume or better protection for the tool than Greycho-I. The uncoated tool got the maximum burned-out volume. The performance of Brocho™ coating fell just above the uncoated cutter (or baseline).

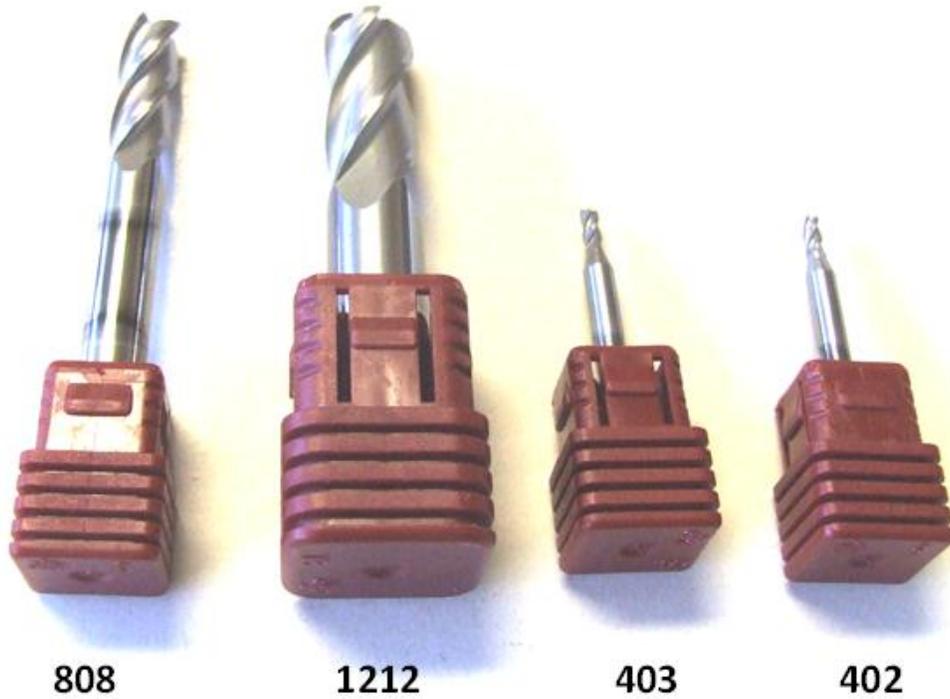
Figure 14(a). Uncoated Carbide Cutting tool received from Triangle Precision that are used in steel machining (lower numbers designates the tool type)

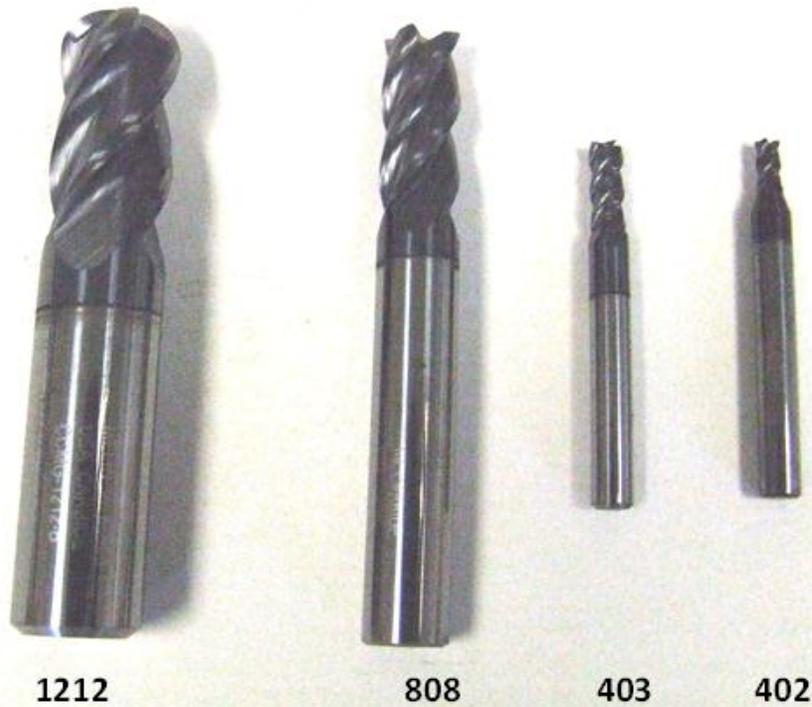
Figure 14(b). Carbide Cutting tool coated with Greycho II™ coatings provided to Triangle Precision for steel machining.

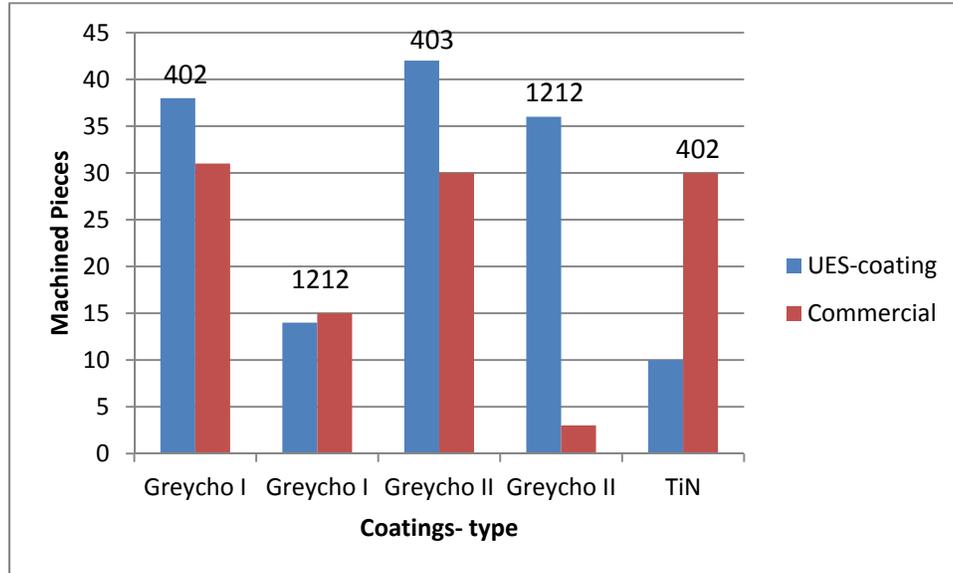
Figure 15. Coating performance, UES vs. Commercial coatings (Triangle Data)

After the coating, they were given back to Triangle to evaluate their performance. They used these tools in their industrial cutting applications and came up with a performance comparison with commercially coated tools used in the same machining conditions. The tool life was measured by number of pieces machined. The results are given in Figure 15, showing the coating type and the tool type (on the top of the bars). From the evaluation results provided by Triangle Precision, it is evident that UES coatings' overall performance was very good compared to standard TiN coating. GreychoTM -II fared very well compared to other two on both cutting tool types and different cutting environments. On the tool type 1212, (3/8 inch round head end mill) GreychoTM -II coating fared significantly better than commercial coating, almost 6:1 ratio. Coating GreychoTM -I also could outperform commercial coating to a certain extent for small tools. However, the performance was not appealing like that of GreychoTM -II. The performance of TiN coating was poor compared to GreychoTM -I, GreychoTM -II or commercial coating. Presently we are working on GreychoTM -II coating optimization and the overall performance.

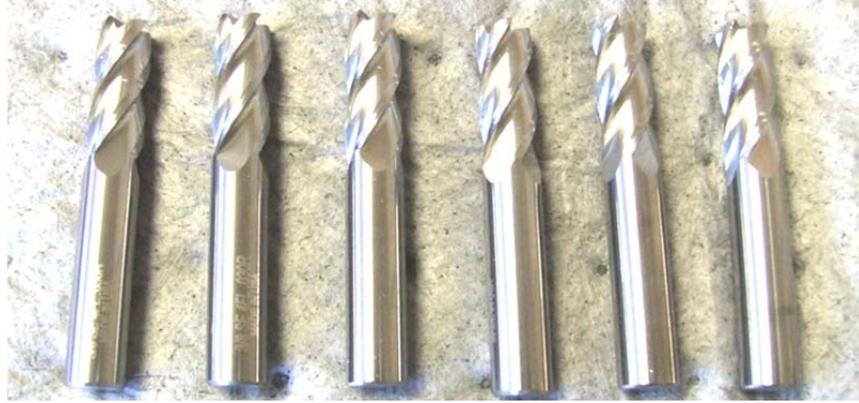
Figure 16(a). Uncoated Carbide Cutting tool received from Kapex that are used in hard steel machining.

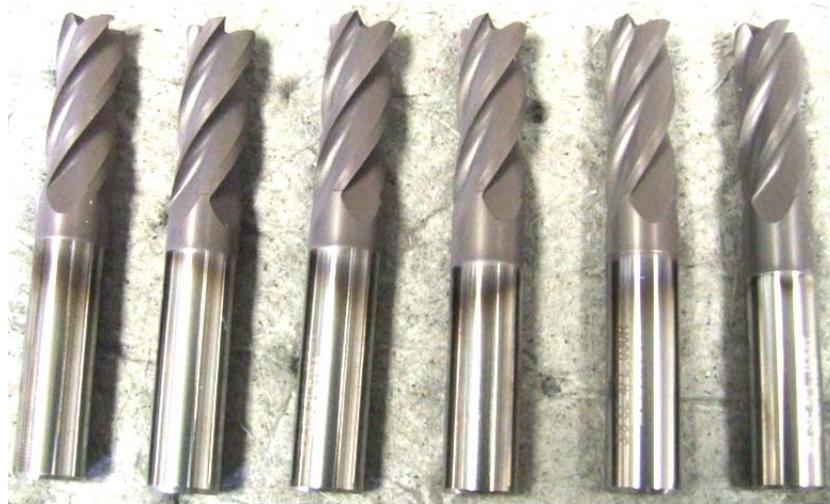
Figure 16(b). Modified Greycho™ coated Carbide Cutting tool provided to Kapex that are used in hard steel machining.

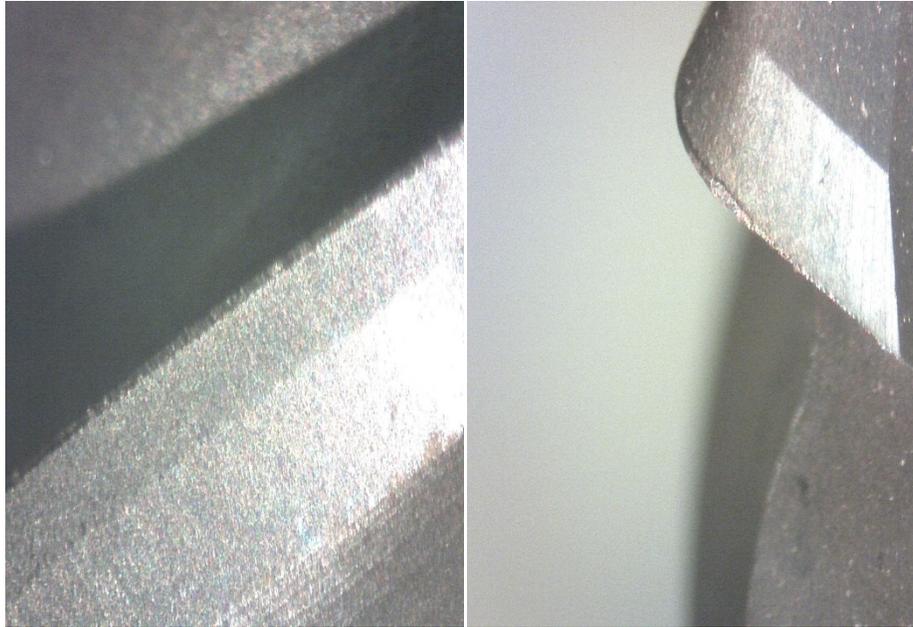
Figure 17(a). Digital micrographs of tools provided to Kapex after 12 hours of severe roughening

Comparing Figures 17(a) and (b), the commercial tools used for only four hours withered and failed due to the excessive wear at the cutting edges and uncontrolled chemical wear adhesion at the flutes whereas Greycho II™ coated tools were sharp even after twelve hours of use.

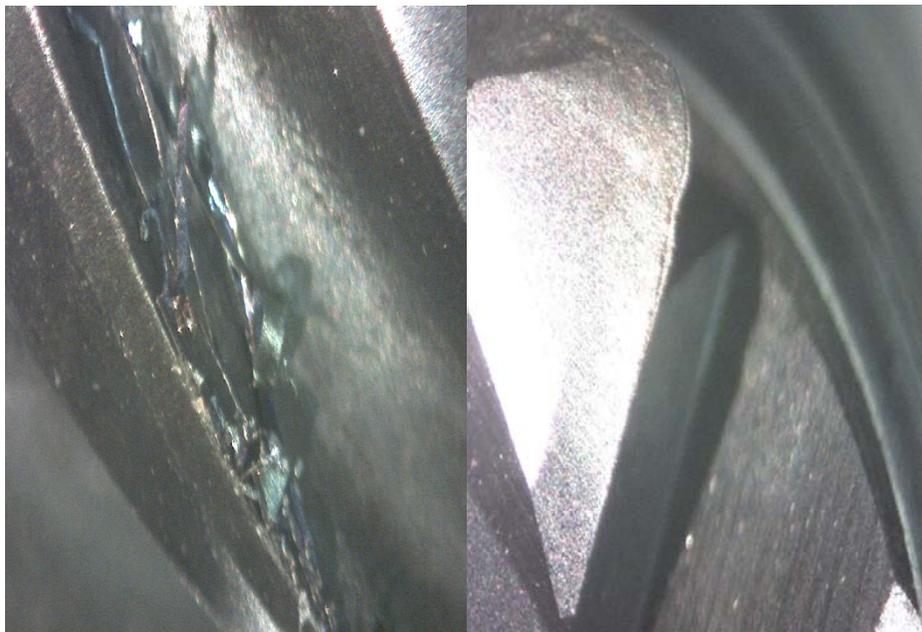
Figure 17(b). Digital micrographs of commercial tools after 4 hours of severe roughening

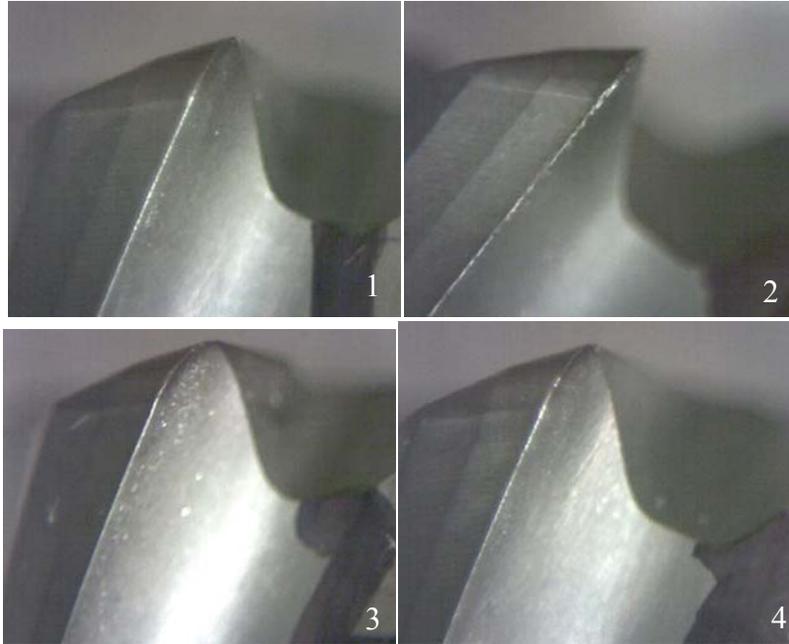
Figure 18(a). Digital micrographs of flutes showing cutting edges coated with Greycho II™

Figure 18(a) and Figure 18(b) show the optical micrographs of a used tool, which were coated with Greycho II™ and a commercially coated tool respectively. The commercial tool is used only for 1/3 duration of cutting time compared to the UES coated tool. It can be seen from the figures that UES coated tools are almost intact while the commercial tools were damaged and not usable. Table 3 shows the tool wear area for each flutes of typical tools tested. It can be seen from the Table that UES coated tools have minimum wear compared to commercial tools. In addition, second-generation coatings from UES out passed the first generation performance significantly.

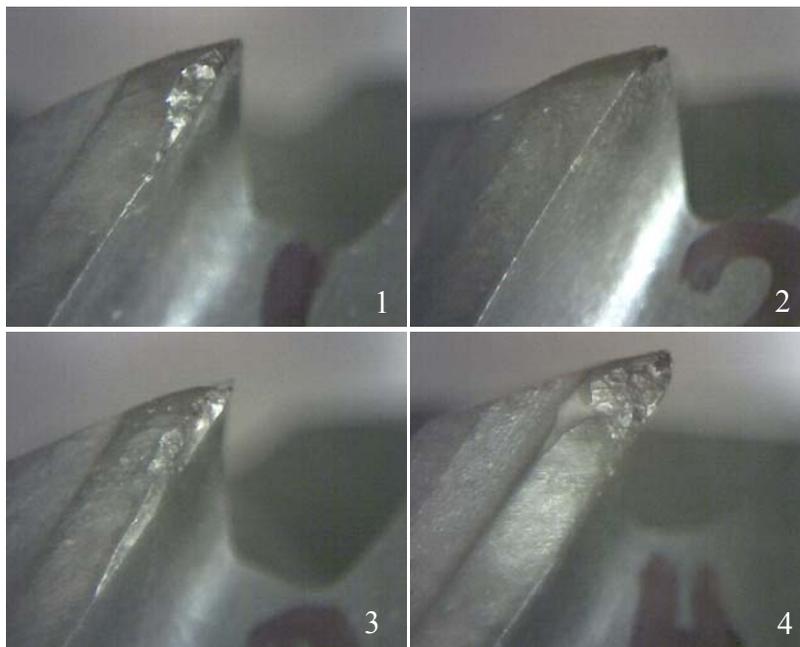
Figure 18(b). Digital micrographs of flutes showing cutting edges coated with Commercial coating

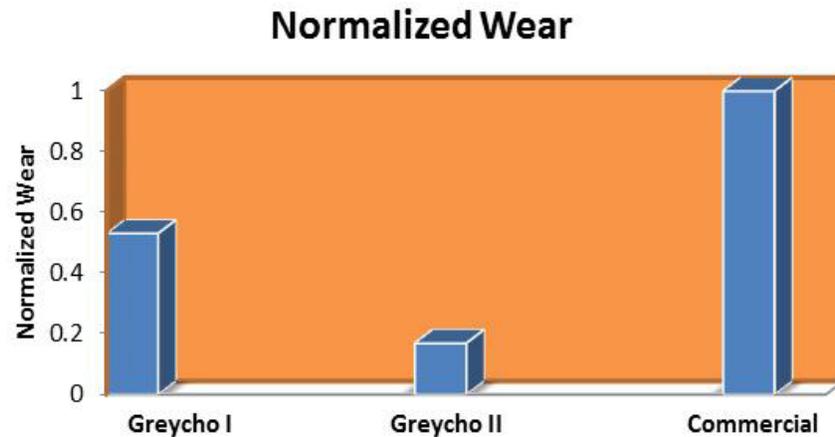
Figure 19. Performance of UES coated Kapex tools compared to commercial coatings

Figure 19 shows the overall performance comparison of UES coated tool compared to commercial coatings based on the data given in Table 3. In the plot, the average wear loss for the commercial coating is normalized and wear losses for UES coated tools are scaled accordingly. In a way, it can be seen that the Greycho II™ coating performed almost *six* times better than the commercial coatings. It is worthwhile to note that the Greycho coatings provided to Triangle Precision also came across the same ratio for the performance improvement for their roughening application.

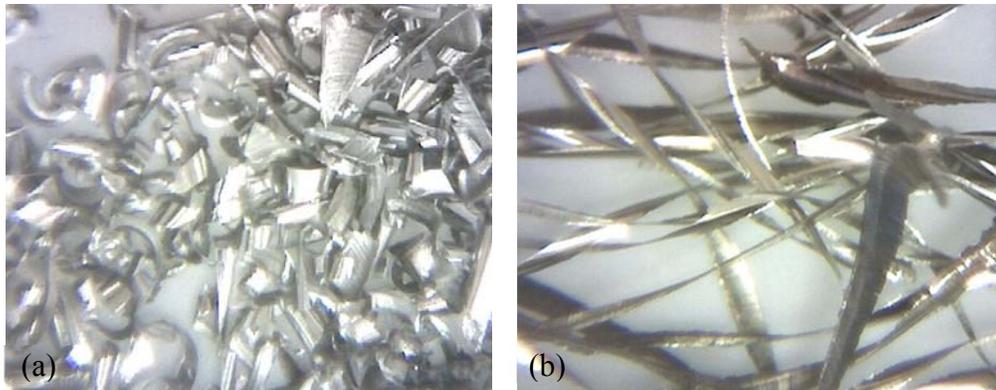
Figure 20. (a) Optical micrograph showing chips (4 hours) collected from commercially coated tools and (b) Optical micrograph showing chips collected (12 hours) from UES coated tools

Figure 20 shows the optical micrograph of multiple chips collected almost four hours into cutting from commercially coated tool (Figure 20(a)) and chips collected from Greycho II™ coated tools in (Figure 20(b)). As we can see chips formed of commercial tools is all broken down into tiny fragments with irregular shapes while Greycho II™ coated tools chips are elongated up to 2-3 cms. This shows the bluntness of commercial tool after four hours of use while Greycho II™ coated tools remain sharp and form long regular elongated chips. Another interesting property of the chip is the number of twist we observe on a single chip and overall color of the chip. As the sharpness of the tools diminishes, the chips formed get more stress during the separation process and get highly plastically deformed (more twists formed) produces more heat and are darkened in color. In the case of sharp tools, all these effects are minimized and chips remain shiny and less deformed. Figure 21 shows the optical micrograph of a single chip collected almost one hour into cutting from commercially coated tool (Figure 21a) and a single chip collected almost ten hours into cutting from Greycho II™ coated tools (Figure 21b).

As we can see chips formed from the commercial tools were darkened and were twisted more into the first hour of cutting while Greycho II™ coated tool produce chips with shiny surface and minimum twists even after ten hours of use. This substantiates the superior performance of Greycho II™ coated tools, which we assessed from the wear area computation made on each flutes and cutting edges reported in the last section.

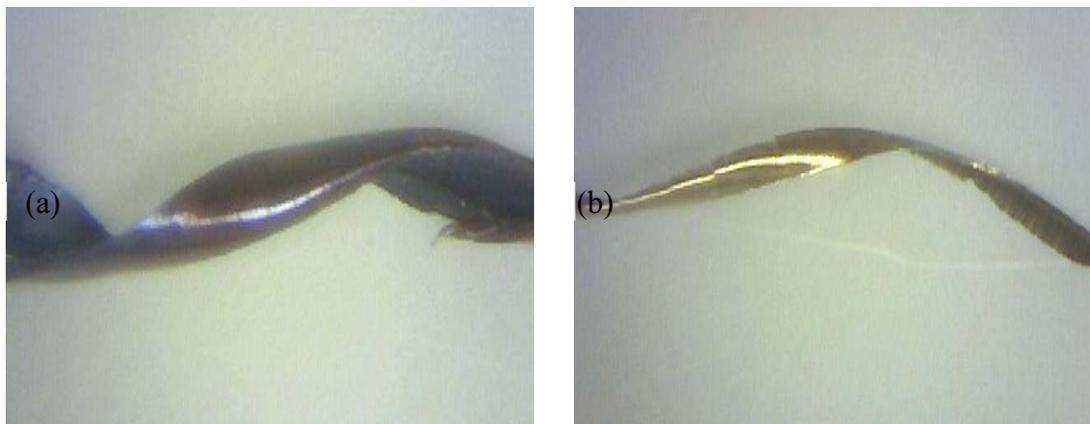
Figure 21. (a) Optical micrograph showing single chip (one hour) collected from commercially coated tools and (b) Optical micrograph showing chips collected from UES coated tools (ten hours)

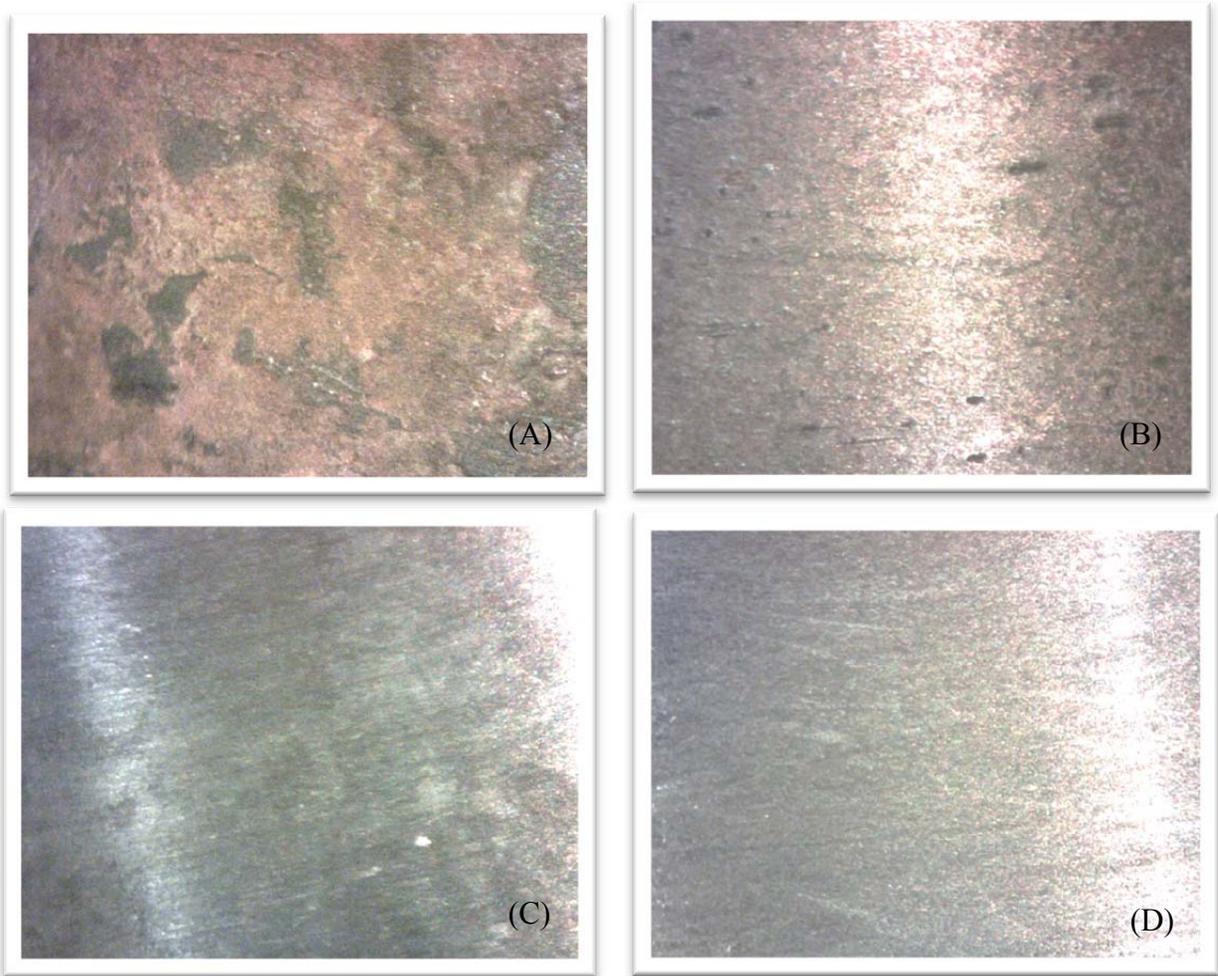
Figure 22. Optical micrograph (50X) of the thermally cycled surface coated with (A) Uncoated pin, (B) Titan Generation I coating, (C) Modified Generation I coating, and (D) Titan Generation II coating

Figure 22 shows optical micrograph of the thermally cycled surface of coated test bars. The less-reactive ceramic coatings (TiN, HfB₂) provides a mechanical barrier to protect the H-13 steel from contacting the reactive molten aluminum alloy. In other words, the soldering reaction could not take place if the coating remains intact over the surface of the H-13 matrix. Figure 22 clearly shows the surface defects formed by soldering for various coatings tested, which also depicts erosive pits, minor cracks or delamination of the coatings.

see from the surface microscopy, the sample D, which is coated with Titan Generation II™ coating shows no damage

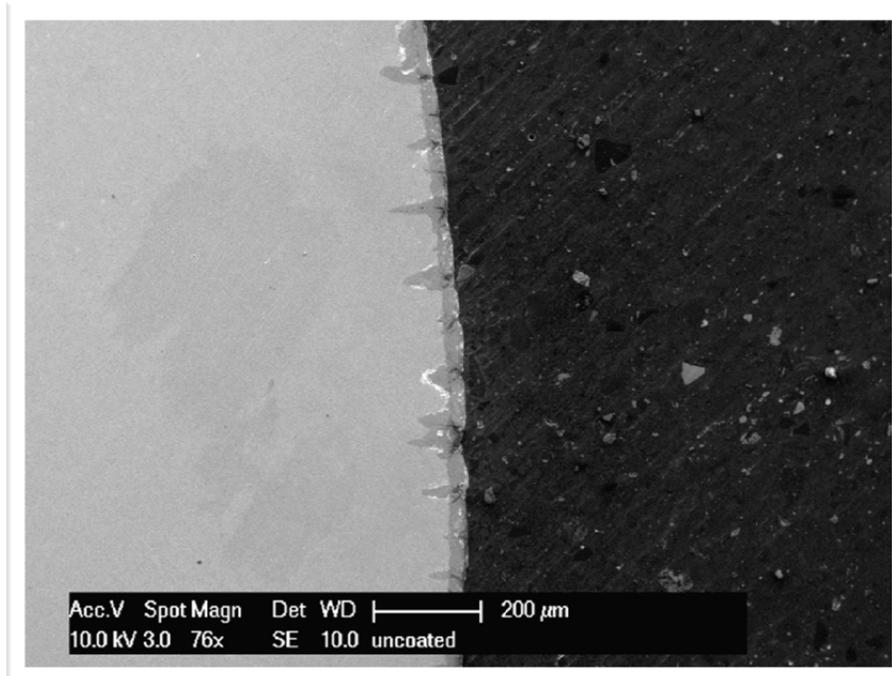
Figure 23(a). Cross section of uncoated pin showing numerous pits formed into the H-13 substrate.

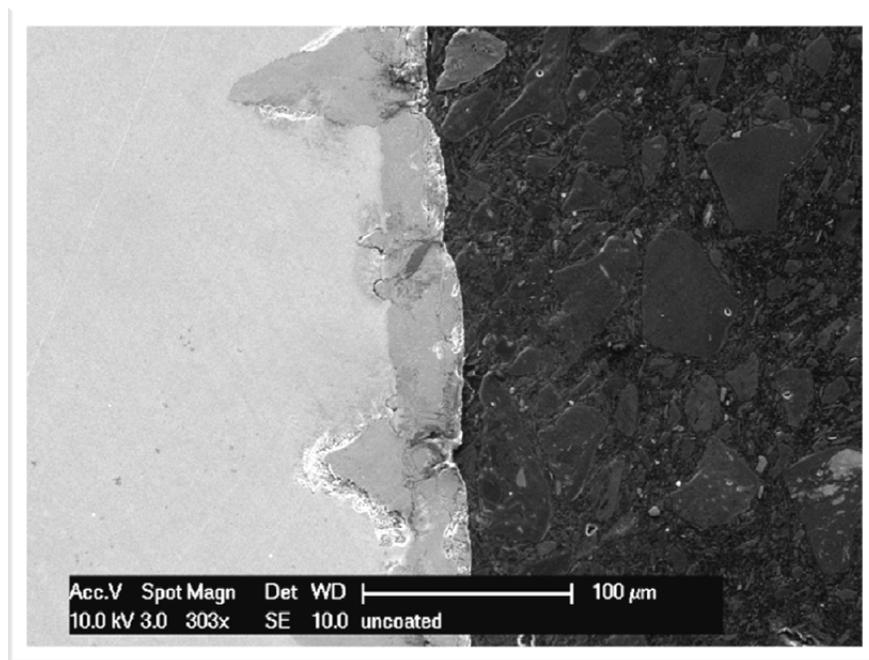
Figure 23(b). Cross section of uncoated pin showing the detailed structure of pits

Figure 23(b) shows the typical image of the soldering area (with 60 microns in lateral direction and 90 microns in depth), which contained the Al-Fe reaction area and the Al alloy area (the eutectic aluminum phase) located in the center of the soldered area. A 15-micron spot scan located in the reacted pit region (in Figure 23b) was used to analyze the elemental distribution of the pit. The graph in Figure 24 shows the atomic percentage of elements at the center of the reacted area. Al and Fe are the main component elements in this image besides oxygen. An important feature shown from this study is that the Al alloy region extends deep into the tip of the pit. Most likely, the Al eutectic phase in the Al alloy region became a liquid phase when molten aluminum heated up the core pin. Convection within the liquid phase accelerates the in-depth growth of the pit. The sharp tip of the Al alloy region also is an indication that the high pressure during the insertion stage of the pin into the molten aluminum alloy may have been transmitted through the liquid eutectic phase to tear the inter-metallic phase apart, forcing liquid to fill the crack thus formed.

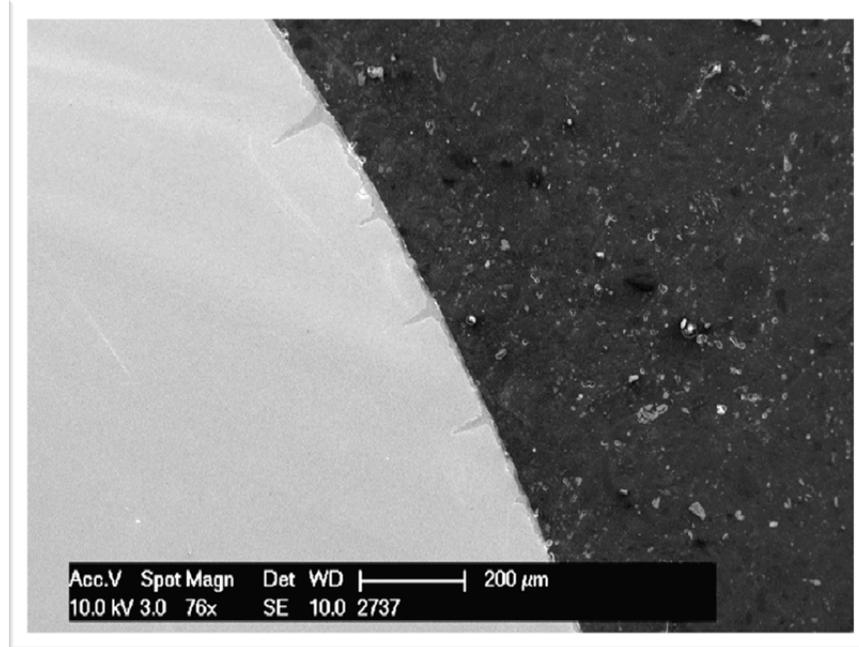
Figure 23(c). Cross-section of Titan Generation I coated pin showing failure of the coating and pits

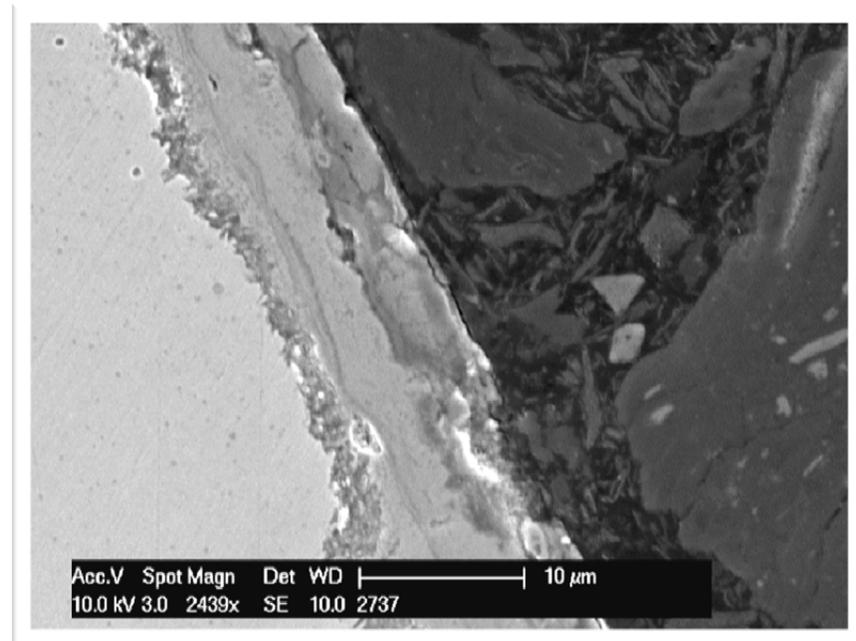
Figure 23(d). Magnified cross-section of Titan Generation I coated pin showing delamination of the coating and steel surface degradation.

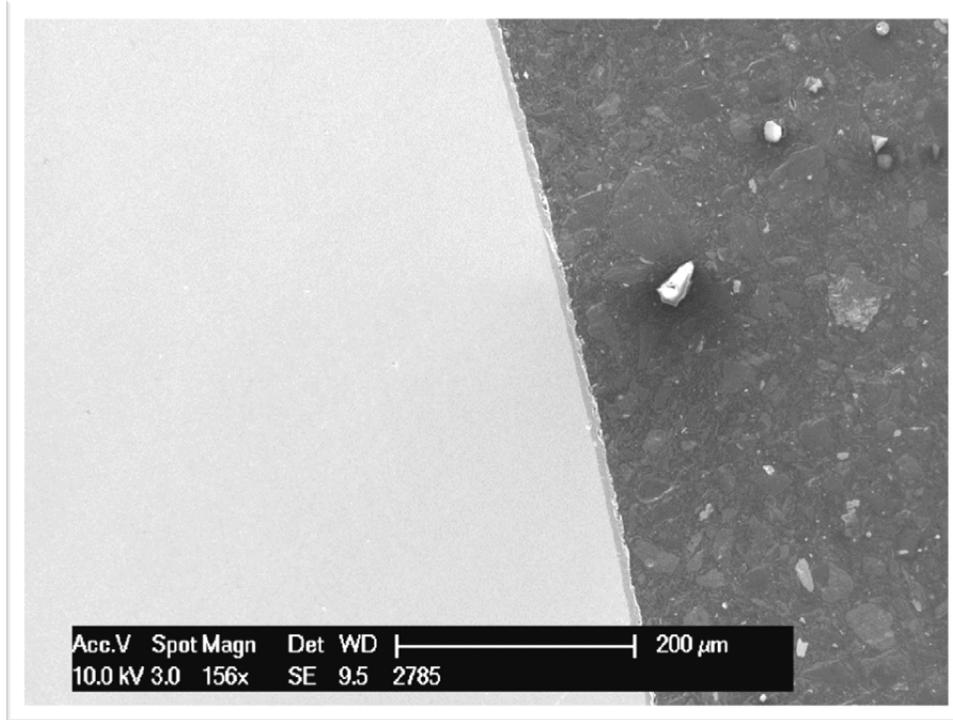
Figure 23(e). Cross-section of modified Titan Generation I coated pin showing overall performance

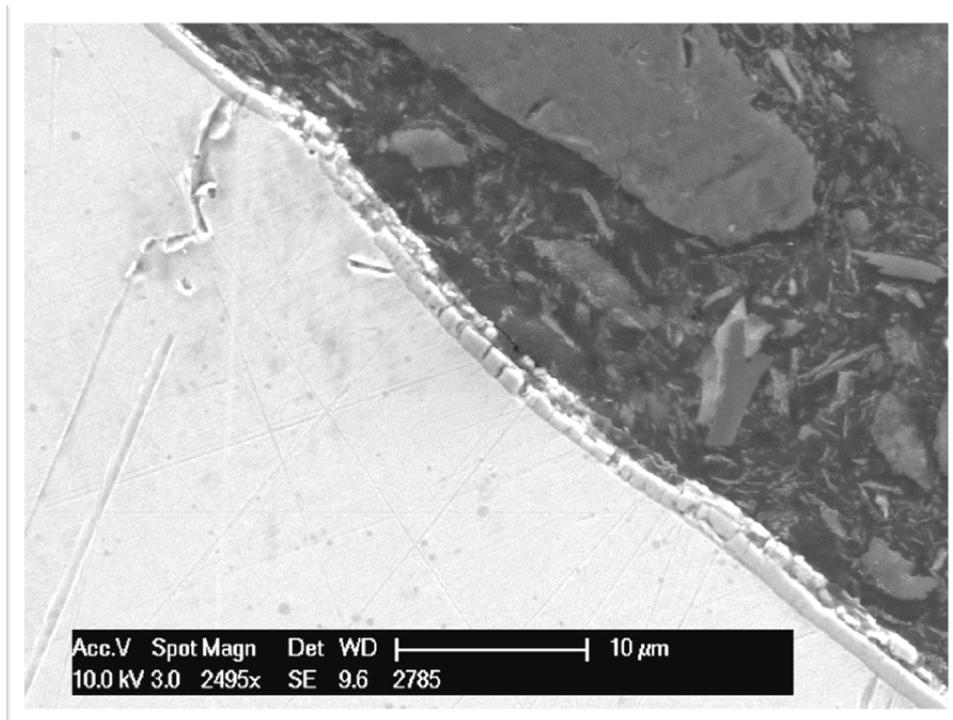
Figure 23(f). Magnified cross-section of Titan Generation I coated pin showing delamination of the coating and steel surface degradation.
