FINAL TECHNICAL REPORT

Project Title: **Multiphase Nano-Composite Coatings for Achieving Energy Optimization**

DOE Award Number: DE-EE0003489

Recipient Organization: UES, Inc.
 4401 Dayton-Xenia Rd.
 Dayton, OH 45432

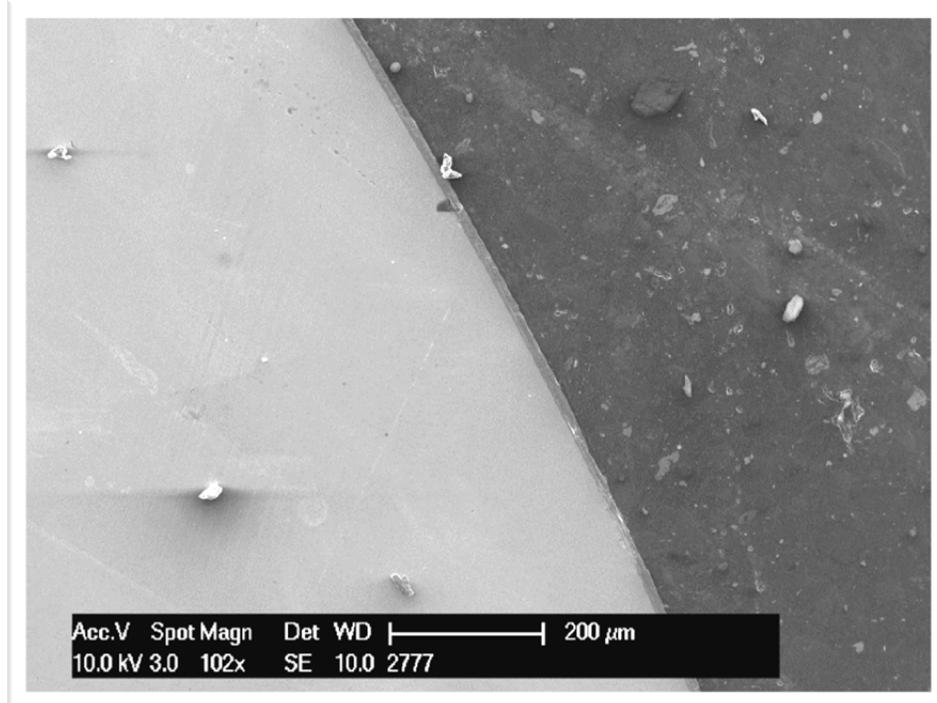
Figure 23(g). Cross section of Titan Generation II coated pin showing undisturbed coating and steel surface.

Figures 23(g) and 23(h) shows the cross sections of the best performing coating. As we can see, this coating (Titan Generation II) is protecting the steel at 7800 dips without much damage to the surface. The H-13 steel rod surface is intact, and the coating remains without any crack or delamination even in the highly magnified picture in Figure 23(h).

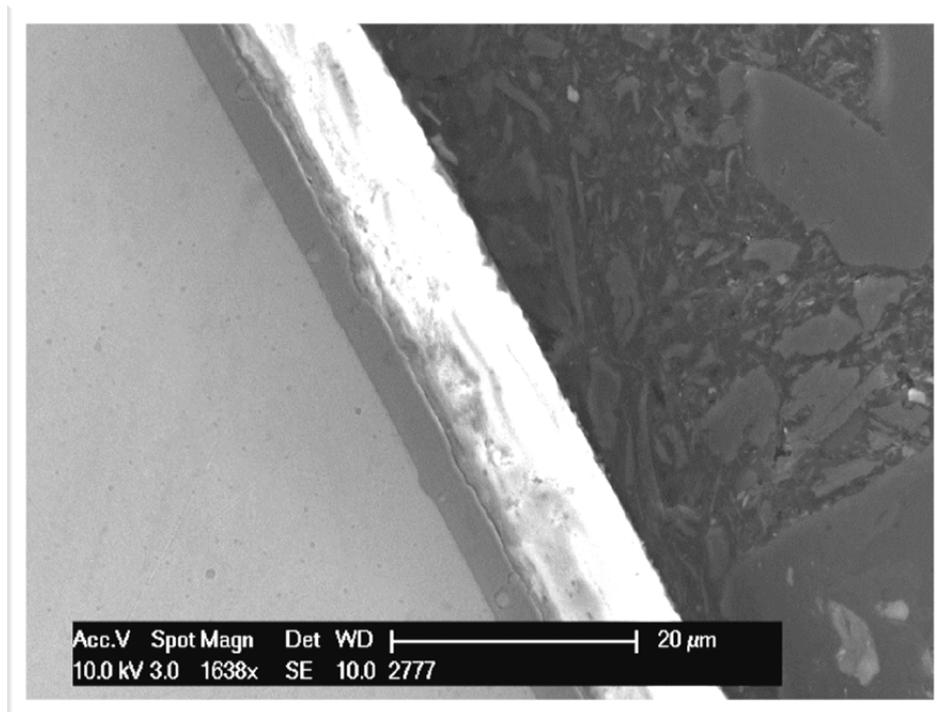
Figure 23(h). Magnified cross section of Titan Generation II coated pin showing undisturbed coating and steel surface.

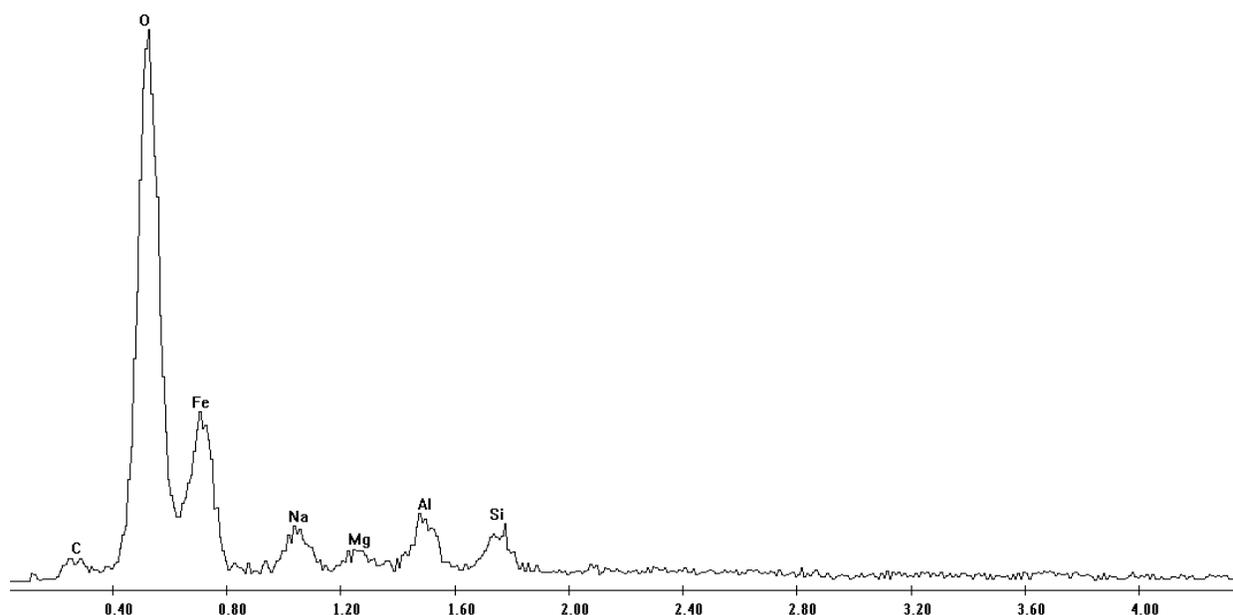
Figure 24. EDS data inside a pit showing the major elements (uncoated pin)

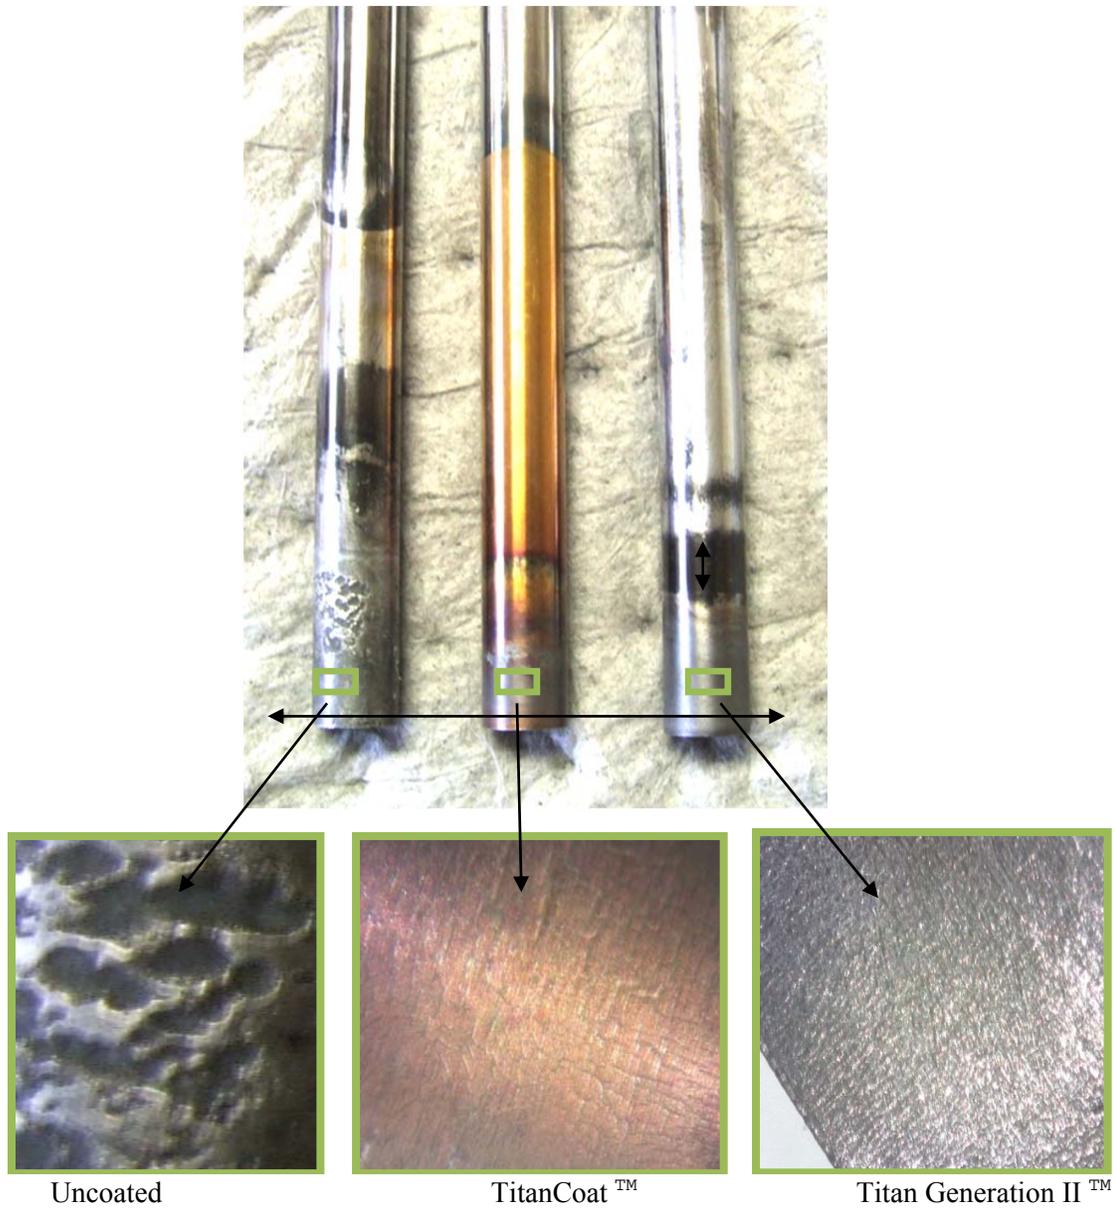
Figure 25. Metal dissolution/thermal stress dipping test results.

changes from a 1000 cycle dip test are shown in Figure 25. The top picture shows digital photo of the rods after the dip. Bottom one-inch length was dipped into the molten aluminum. The dip cycle consists of 5 seconds in molten aluminum, transferred to room temperature water, dipped for 4 seconds. The temperature of the aluminum bath was held at 850 °C. From the overall look, the uncoated one is severely damaged and other two do not seem to have been affected much. The bottom frames of Figure 25 show the magnified surface morphology of each rod. The green rectangular regions shown in the top pictures are selected in the magnified pictures. It is evident from the pictures that uncoated bare rod under goes severe damage like pitting and eroding into the solid rod. TitanCoat™ coated sample shows only surface cracks that are less severe compared to uncoated baseline. Newly developed Titan generation II™ coated sample is showing minimal damage to the sample surface. No cracks seem to be penetrating into the solid body. To check this we have made cross sections of these rods at position shown by the horizontal arrow in Figure 25. The sections were mounted and polished to one-micron roughness and examined under scanning electron microscope (SEM). Figure 26 shows the results of this study. Figure 26(a), (b) and (c) show the bare, the TitanCoat™ coated and the Titan Generation II™ coated rods respectively. We purposely avoided the highly pitted area for the sectioning. From Figure 26(a) it is evident that aluminum is attacking solid rod after penetrating into it through surface cracks. From Figure 26(b), TitanCoat™ coated sample still keeps a slight portion of the coating even though the coating is partially detached by the aluminum. That gives protection to the substrate from the molten aluminum. Figure 26(c) shows the effect of Titan Generation II™ coating in protecting the substrate. As we can see, the coating is almost intact after 1000 dip cycles. Coating does not seem to be affected by the thermal stress cycles between the molten aluminum bath and the room temperature water. The substrate seems to be intact under the coating. It may take several more thermal cycles to observe some damage to this coating system.

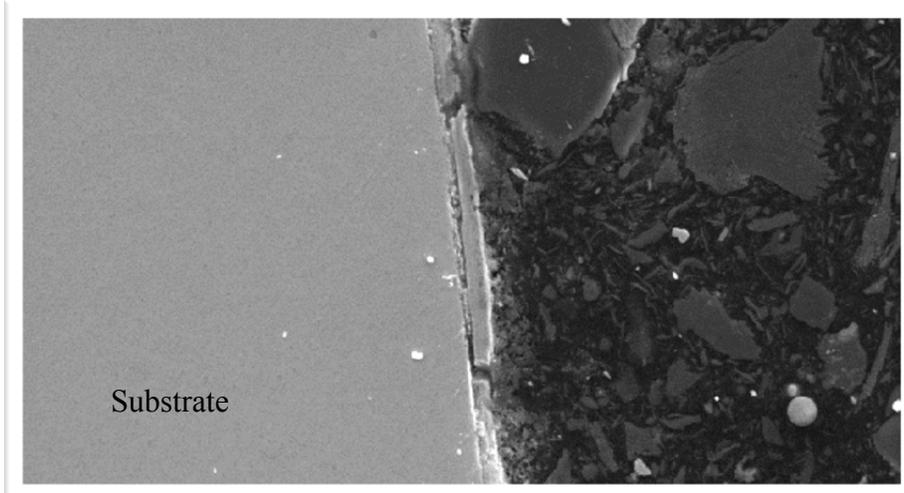
Figure 26(a). SEM micrograph showing X-section of bare rod

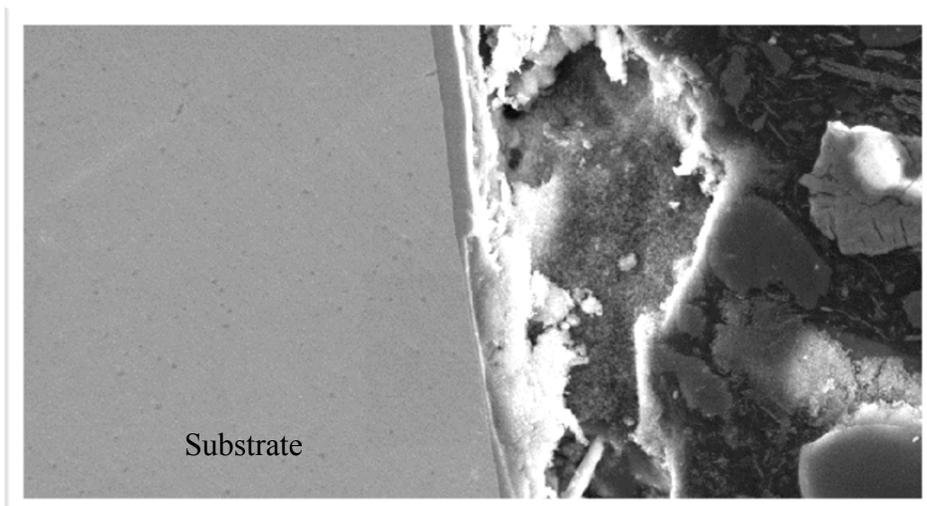
Figure 26(b). SEM micrograph showing X-section of Titan coated rod

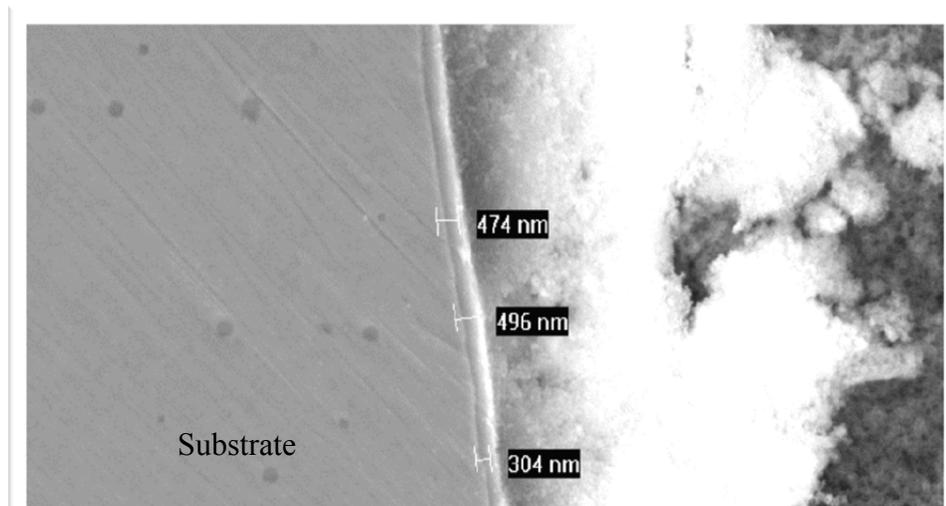
Figure 26(c). SEM micrograph showing X-section of Titan Generation II coated rod

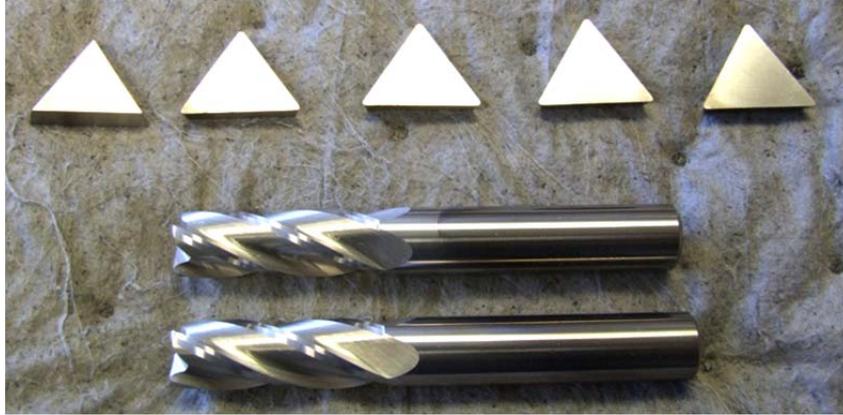
Figure 27. End mills and triangular cutters coated with MoN-Cu using the sputter ion plating process.

The sputter ion plating system of ANL has been designed, built, and installed by the CemeCon-USA Co. under a CRADA supported by DOE-Office of Transportation Technologies. It has two independently controllable targets that can be made of Mo and Cu. In the presence of Ar+N₂ gases in the gas discharge plasmas, one can easily synthesize MoN-Cu coatings and deposit them onto various work pieces in its large deposition volume (typically 1 m³). Very high ionization efficiency of this deposition system insures pore-free (smooth) microstructure and strong adhesion between coating and substrate materials. Figure 27 shows the end mills and triangular cutters coated by this process.

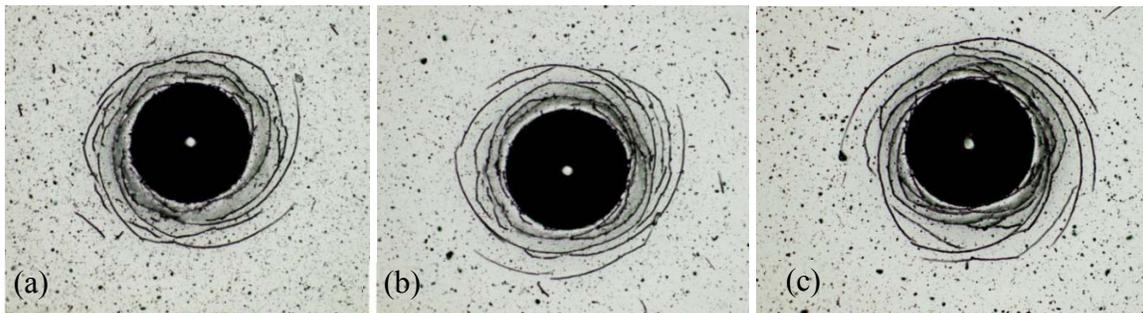
Figure 28. Rockwell C (a) middle, (b) 1st corner and (c) 2nd corner on steel witness

Adhesion of these films to the substrate was measured by Mercedes Rockwell C indentation method, a maximum load of 150 Kg is applied onto the coating and resulting indentation crater is studied for the mechanical characteristics of these coating. Figure 28 shows the micrographs for these indentation craters. As it is seen below, adhesion of the coating to substrate is rated as HF1 (very good).

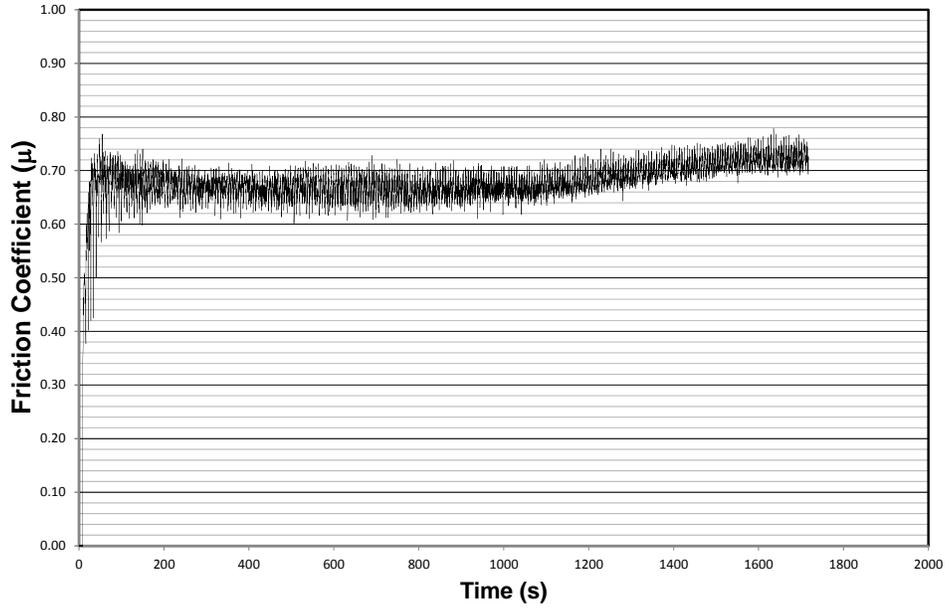
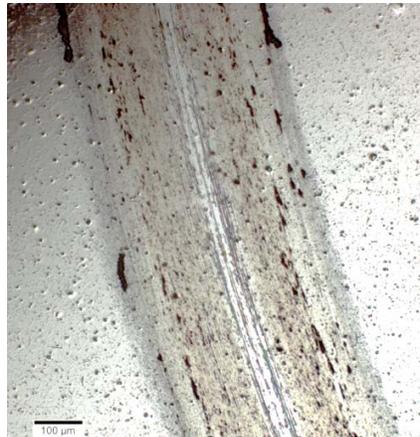
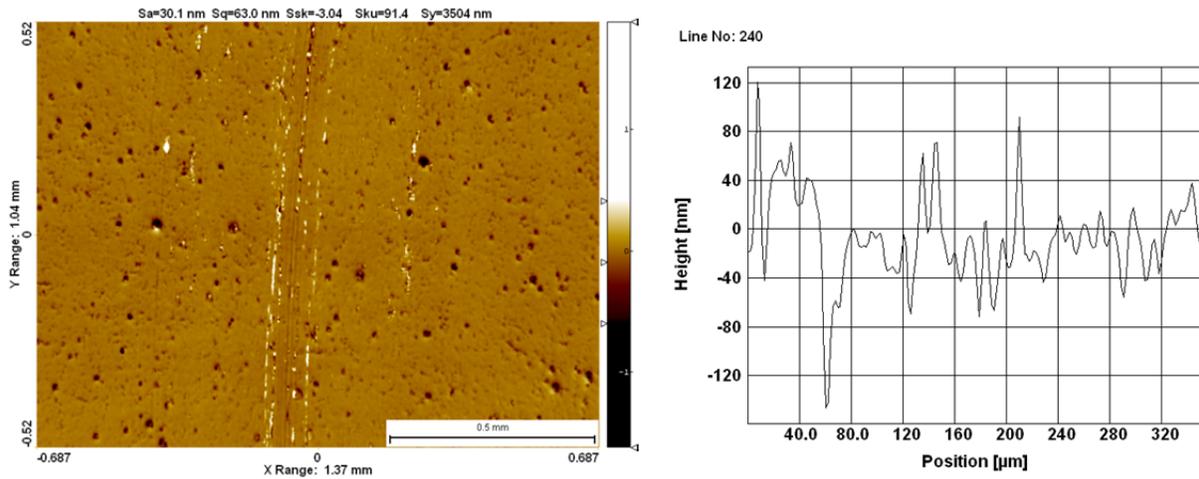
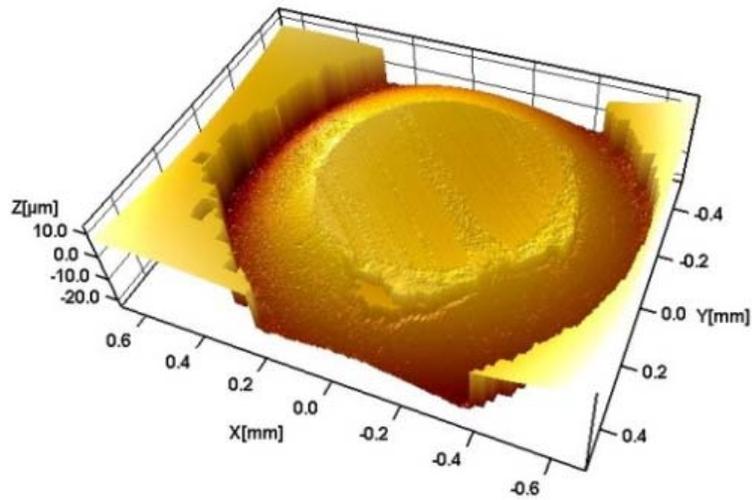
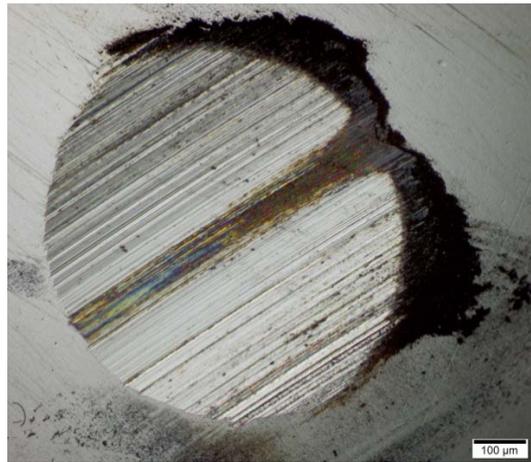
Figure 29(a). Friction trace, Friction coefficient Vs Time

Figure 29(b). Wear scar of MoN-Cu flat

Figure 29(c). Wear scar profilometry of the flat with line scan

Figure 29(d). 3D-Wear scar profilometry of the ball

Figure 29(e). Ball micrograph

Friction and wear of these coatings are studied with a ball on flat tribometer. Following are the conditions used in this test. A 1/4" 52100 ball was used for this test. The normal load was set to 2N with a track diameter of 30 mm and 10 rpm resulting in a linear speed of 16mm /s. The relative humidity of the surrounding is held at 44% and the total run lasted for 1700 sec. completing about 285 revolutions per each run. This test involved no explicit lubricants. Figure 29(a) shows the friction trace from this test. The average coefficient of friction remained around 0.7 throughout the test. Figure 29(b) shows the wear scar of the MoN-Cu coated flat. Figure 29(c) shows wear scar profilometry of the flat with the line scan. The profilometry shows only nominal wear on the coated surface. Figures 29(d) and 29(e) show 3D-Wear scar profilometry of the ball and the ball micrograph respectively. It is evident from Figure 29(e) that the steel ball has significant wear at the contacting area.

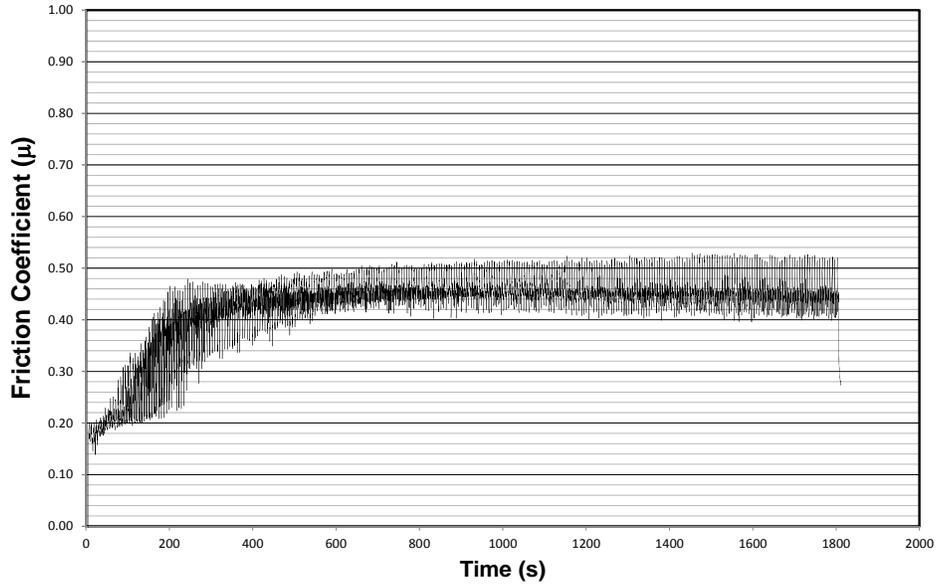
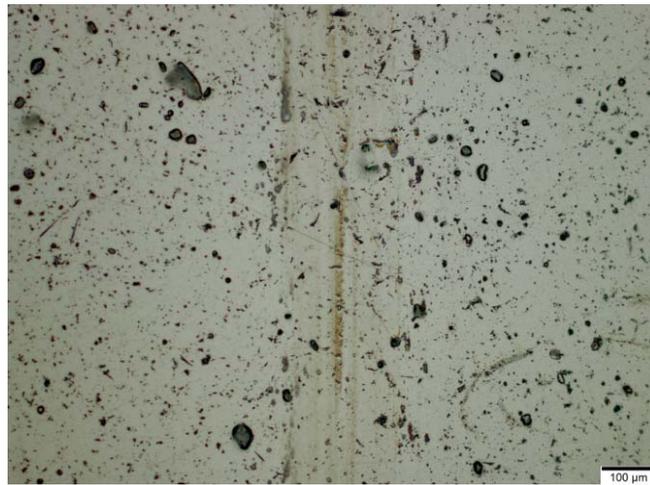
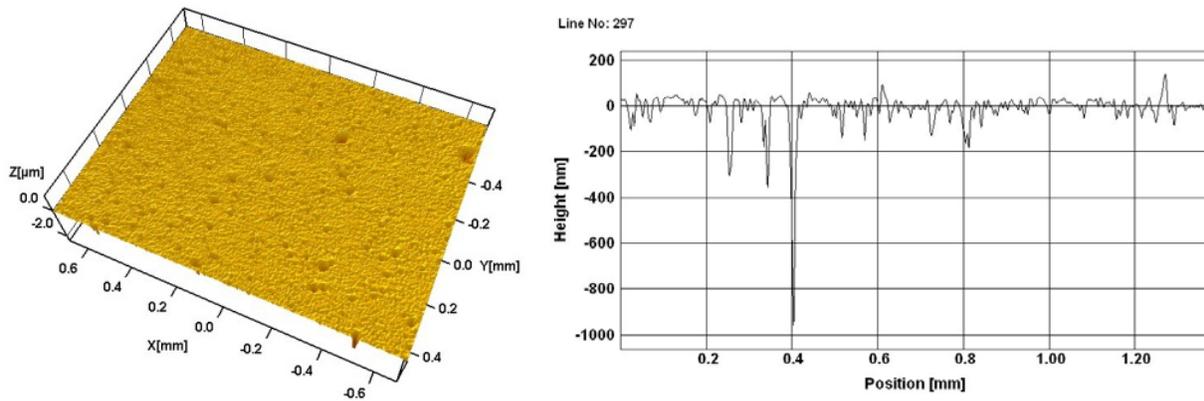
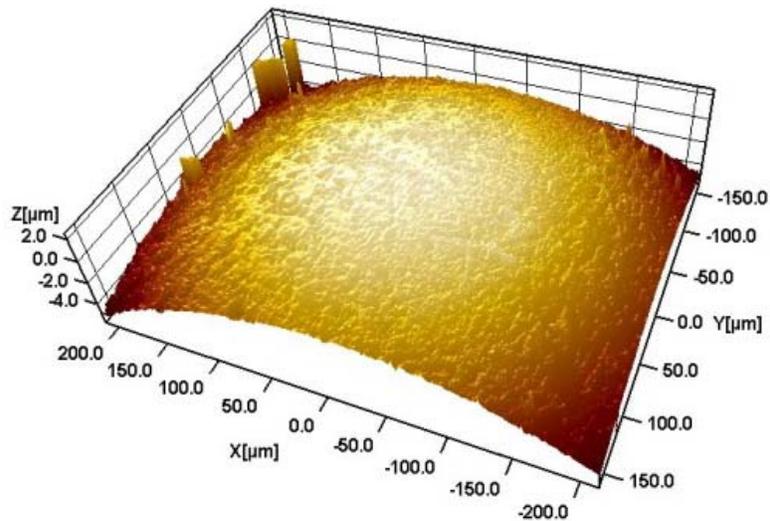
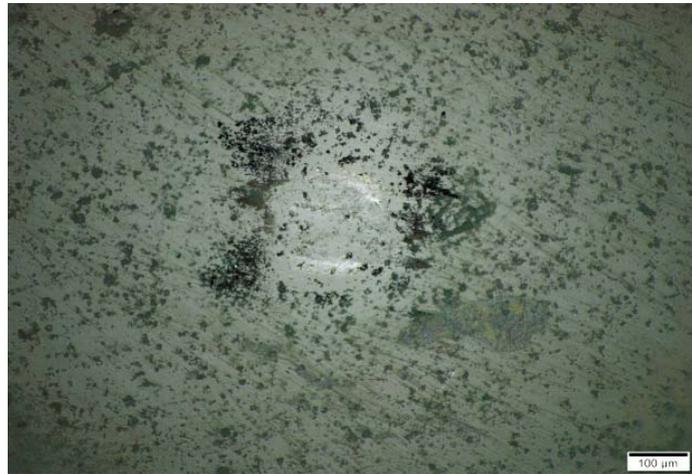
Figure 30(a). Friction trace, Friction coefficient Vs Time

Figure 30(b). Wear scar of MoN-Cu flat

Figure 30(c). Wear scar profilometry of the flat with line scan

Figure 30(d). 3D-Wear scar profilometry of the ball

Figure 30(e). Ball micrograph

Friction and wear of these coatings are studied with a ball on flat tribometer. Following are the conditions used in this test. A 1/4" alumina ball was used for this test. The normal load was set to 2N with a track diameter of 26 mm and 10 rpm resulting in a linear speed of 14mm /s. The relative humidity of the surrounding is held at 44% and the total run lasted for 1800 sec. completing about 300 revolutions per run. This test involved no explicit lubricants. Figure 30(a) shows the friction trace from this test. The average coefficient of friction remained around 0.45 throughout the test. Figure 30(b) shows the wear scar of the MoN-Cu coated flat. Figure 30(c) shows wear scar profilometry of the flat with the line scan. The profilometry shows almost no wear on the coated surface. Figures 30(d) and 30(e) show 3D-Wear scar profilometry of the ball and the ball micrograph respectively. It is evident from Figure 30(e) that the alumina ball has no significant wear at the contacting area.

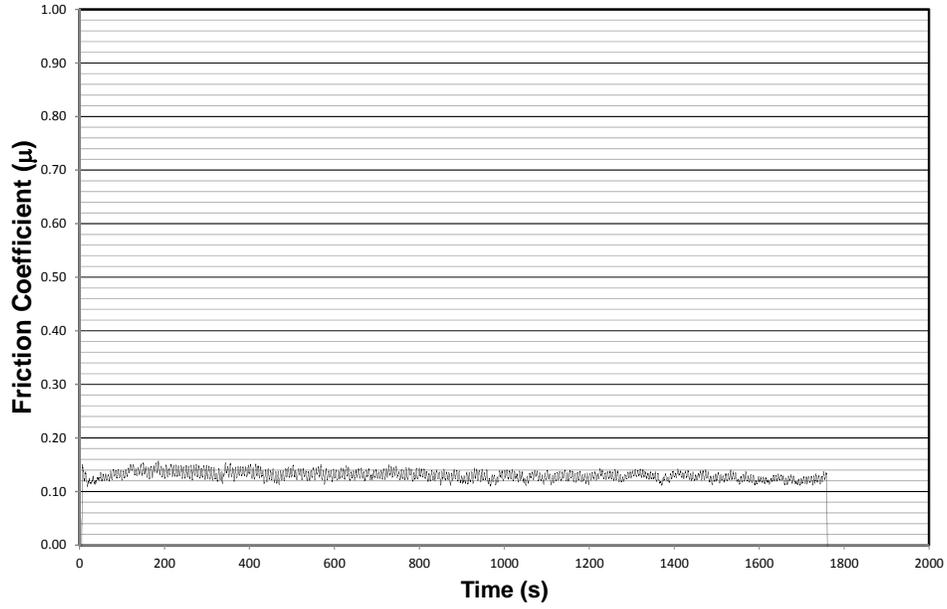
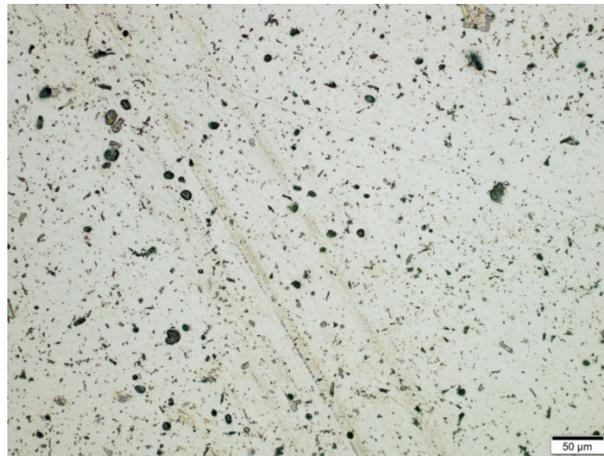
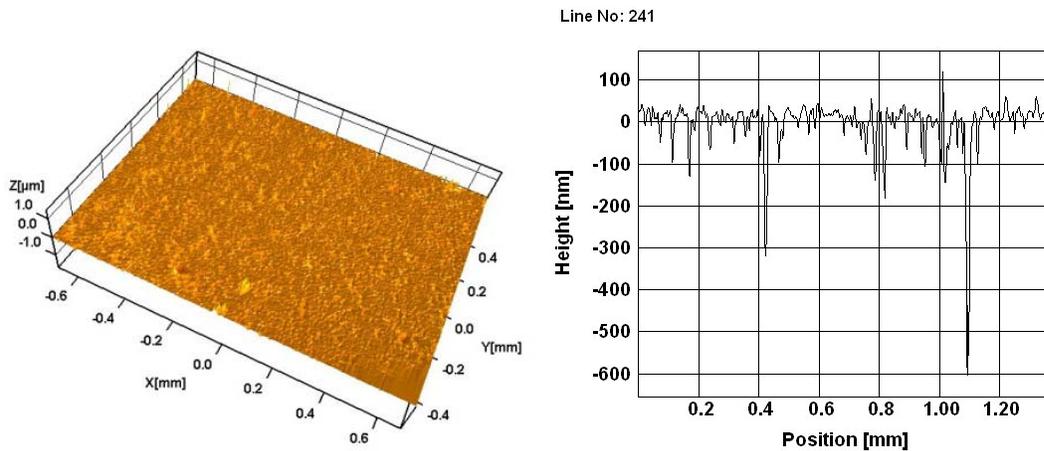
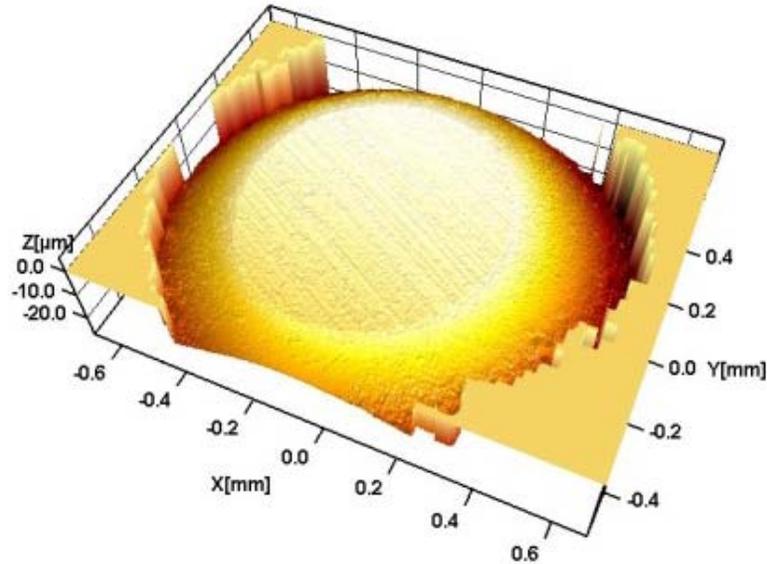
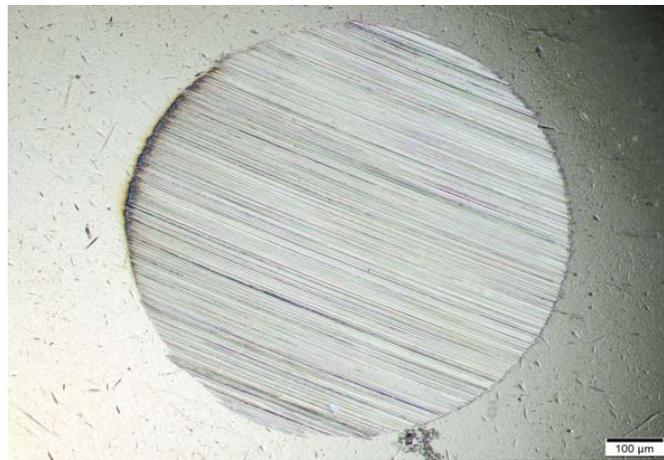
Figure 31(a). Friction trace, Friction coefficient Vs Time

Figure 31(b). Wear scar of MoN-Cu flat

Figure 31(c). Wear scar profilometry of the flat with line scan

Figure 31(d). 3D-Wear scar profilometry of the ball

Figure 31(e). Ball micrograph

Friction and wear of these coatings are studied with a ball on flat tribometer. Following are the conditions used in this test. A $\frac{1}{4}$ " 52100 steel ball was used for this test. The normal load was set to 2N with a track diameter of 26 mm and 10 rpm resulting in a linear speed of 14mm /s. The relative humidity of the surrounding is held at 44% and the total run lasted for 1800 sec. completing about 300 revolutions per run. This test involved the lubricants PA04. Figure 31(a) shows the friction trace from this test. The average coefficient of friction remained around 0.12 throughout the test. Figure 31(b) shows the wear scar of the MoN-Cu coated flat. Figure 31(c) shows wear scar profilometry of the flat with the line scan. The profilometry shows almost no resultant wear on the coated surface. Figure 31(d) and Figure 31(e) show 3D-Wear scar profilometry of the ball and the ball micrograph respectively. It is evident from Figure 31(e) that the steel ball had significant wear at the contacting area.

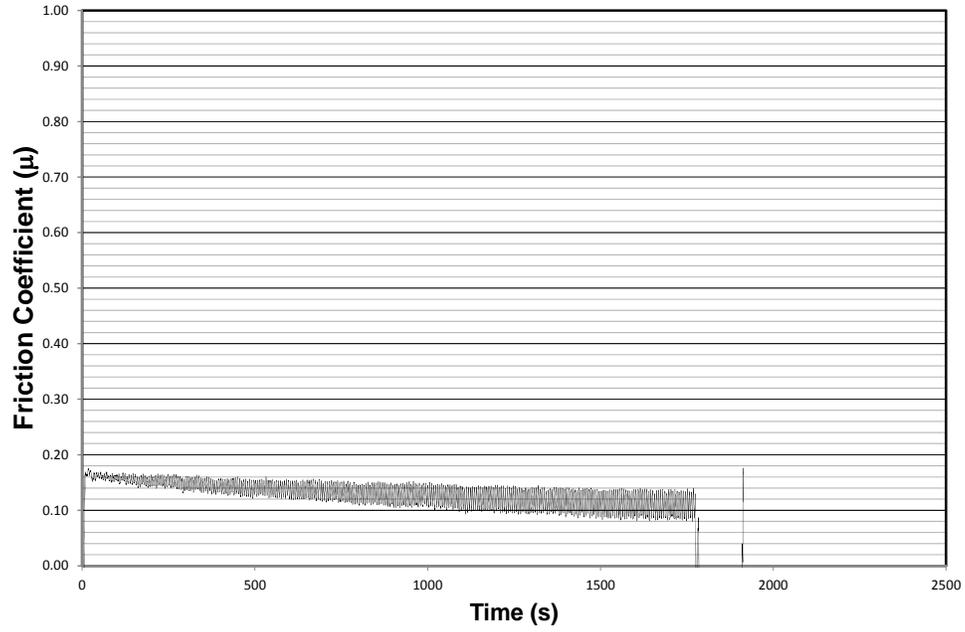
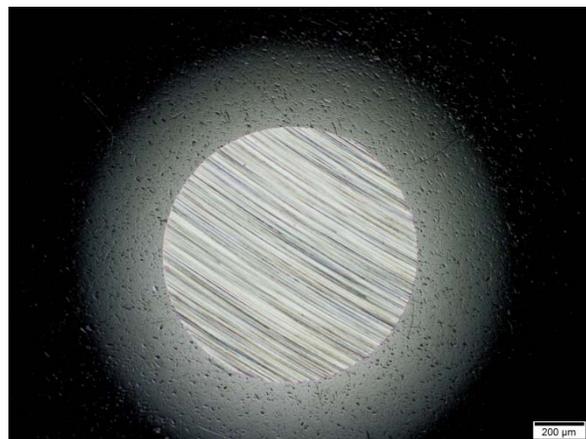
Figure 32(a). Friction trace, Friction coefficient Vs Time

Figure 32(b). Ball micrograph (reasonable wear)

Friction and wear of these coatings are studied with a ball on flat tribometer. Following are the conditions used in this test. A 1/4" 52100 steel ball was used for this test. The normal load was set to 2N with a track diameter of 30 mm and 10 rpm resulting in a linear speed of 16mm /s. The relative humidity of the surrounding is held at 44% and the total run lasted for 1800 sec. completing about 300 revolutions per run. This test involved Valvoline 5W30 as the lubricant. Figure 32(a) shows the friction trace from this test. The average coefficient of friction began with a higher value around 0.17 and reduced to 0.1 towards the end of the test. The wear on the flat could not be seen. Figure 32(b) show micrograph of the ball wear scar. It is evident from Figure 32(b) that the steel ball has reasonable wear at the contacting area.
